## GIZA PLATEAU MAPPING PROJECT 2006–2007 SEASON

Mark Lehner

### The Khentkawes Town (KKT)

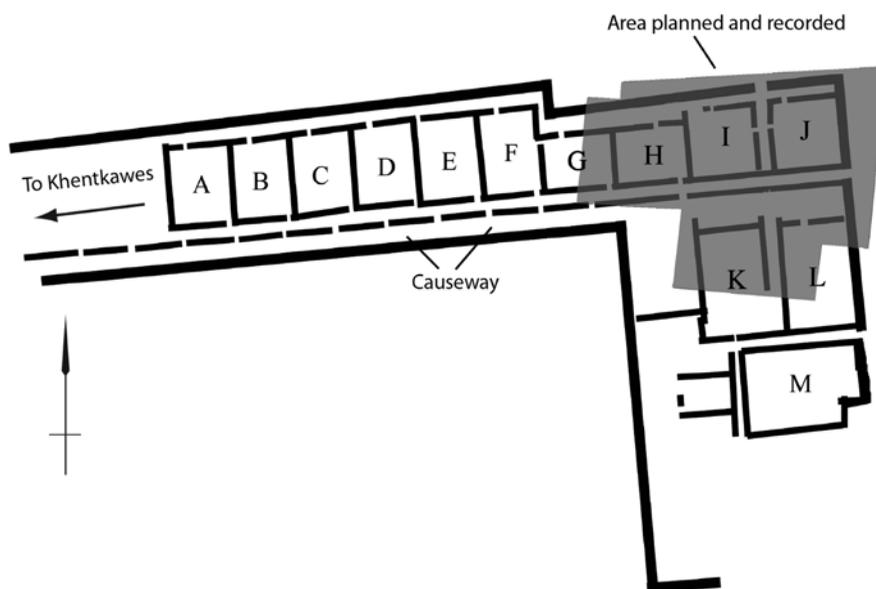
Figure 1. Schematic plan of the Khentkawes Town

Between late January and early April 2007, Lisa Yeomans, with Pieter Collet, supervised work in the KKT, the town, 300 m west of our Area A site, attached to the gigantic tomb of Khentkawes, an enigmatic queen who ruled at the end of the Fourth Dynasty (see Lehner 2006). Altogether Yeomans and Collet cleared, mapped, and assigned feature numbers over an area about 35 × 55 m. North of our 2005 work, the area spans the causeway leading to the Khentkawes tomb and includes the remains of three buildings in the eastern end of the “leg” of the town and a portion of two buildings in the “foot” (fig. 1).

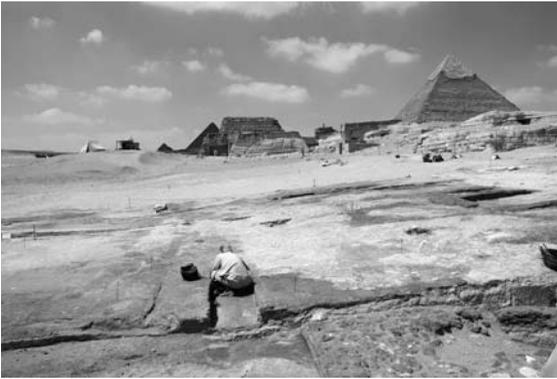
*Figure 2. Clearing the KKT causeway entrance. View to the west*

When Yeomans cleared the entrance to the causeway (fig. 2) she found a large limestone

pivot socket that projected into the causeway from the north wall and was much too large for the width of the causeway. The pivot and its jamb belonged to a doorway that preceded the causeway. This doorway must have been fitted with a swinging wooden door that would have been roughly 1.7 m wide (fig. 3).

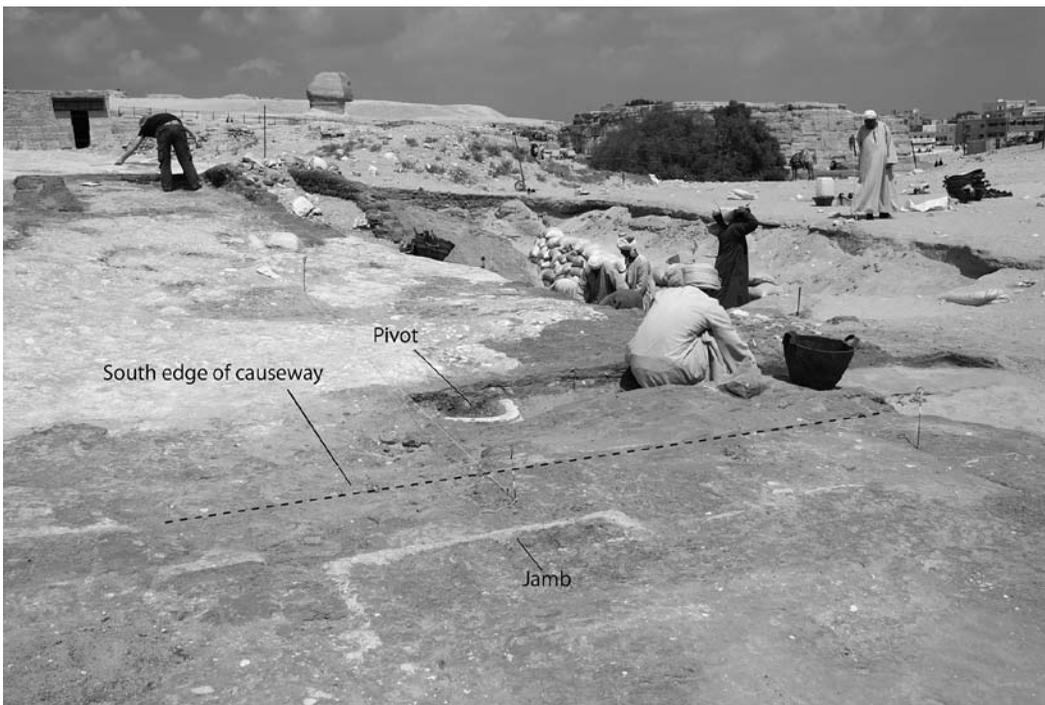
*Figure 3. Doorway in an early phase building in the KKT. View to the northeast*

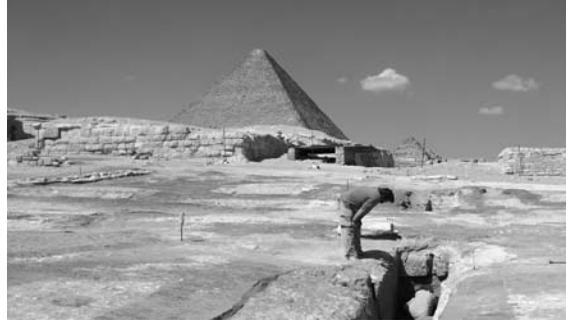
*Figure 4. The tunnel under the KKT causeway for the north–south street. View to the north*

After the inhabitants built the long east–west causeway, crossing and cutting off the north–south street, they quarried out a tunnel or underpass that allowed passage from the eastern end of the KKT “leg” to the “foot” of the town. The underpass, a meter or less wide, sinks 2.47 m at its deepest point (fig. 4). The quarrymen never finished the tunnel, leaving on the floor a series of humps rising up to half a meter, which would have made any passage difficult.

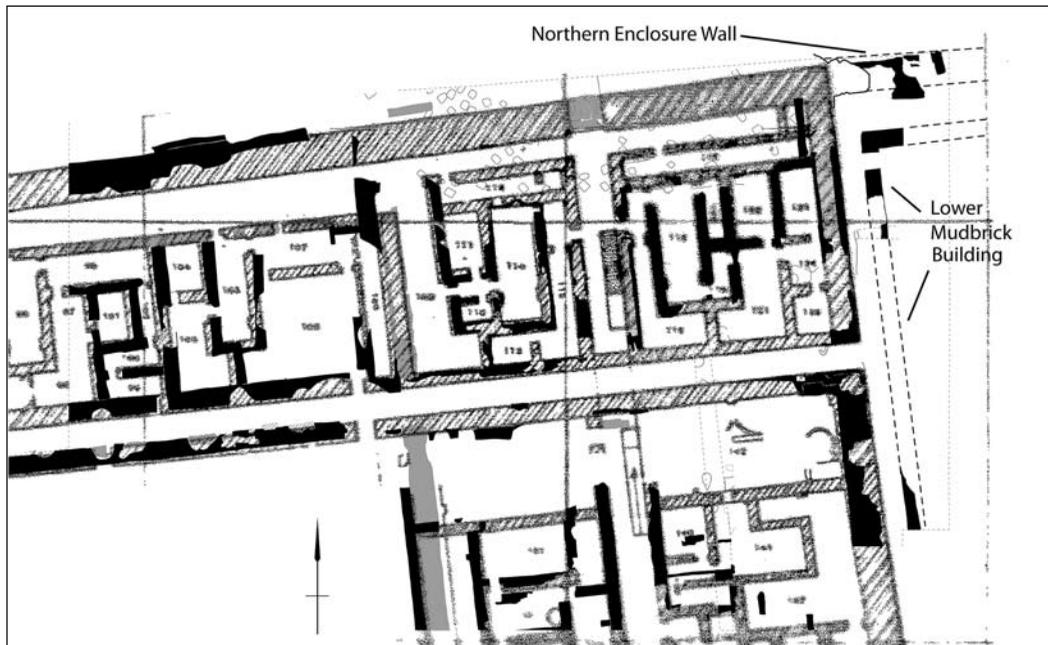
*Figure 5. Wall remnants planned in 2007 in KKT overlaid on Selim Hassan's plan. Mudbrick walls are black, limestone walls gray (Not to scale)*

When Yeomans cleared east of the KKT she found evidence that the settlement continued eastward. Beyond the end of the causeway she located the northwest corner of a mudbrick building with meter-thick walls. It was separated from the KKT by a corridor 2.44 m wide and lay at a lower elevation. The corridor was accessed by a door in the northern KKT enclosure wall, which extends east beyond the northeastern corner where the town makes its L-shaped turn (fig. 5).

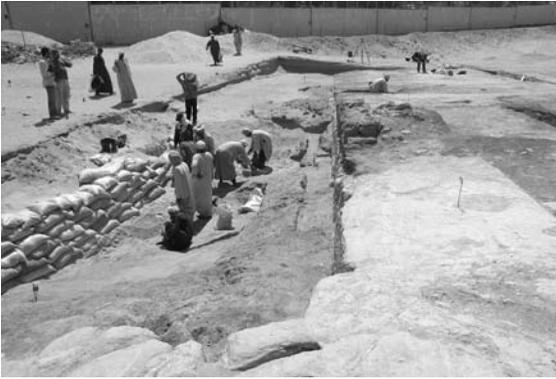
*Figure 6. The east quarry edge and the lower mudbrick building at the east end of the KKT. View to the south*

Yeomans discovered that the bedrock surface drops vertically immediately under the eastern side of the eastern enclosure wall of the KKT. The enclosure wall respects and runs exactly along the drop of the ledge. The lower mudbrick building extends more than 28 m north–south along this ledge (fig. 6).

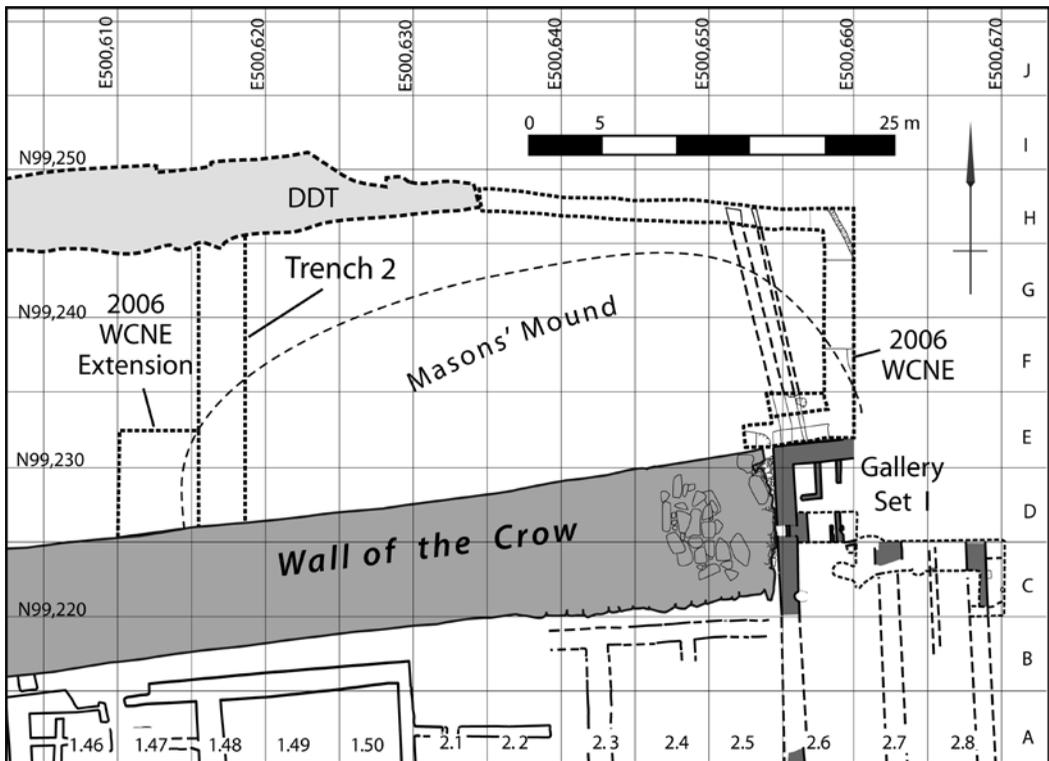
*Figure 7. Map of the WCN and WCNE operations*

Lisa Yeomans supervised our 2006 operations north of the eastern end of the Wall of the Crow (WCNE) (fig. 9). She excavated a connector trench between the DDT and our 2002 trench, which runs north from the northern mudbrick wall of Gallery Set I. She also excavated from the southern end of the 2002 trench to the northeast corner of the Wall of the Crow (see fig. 7).

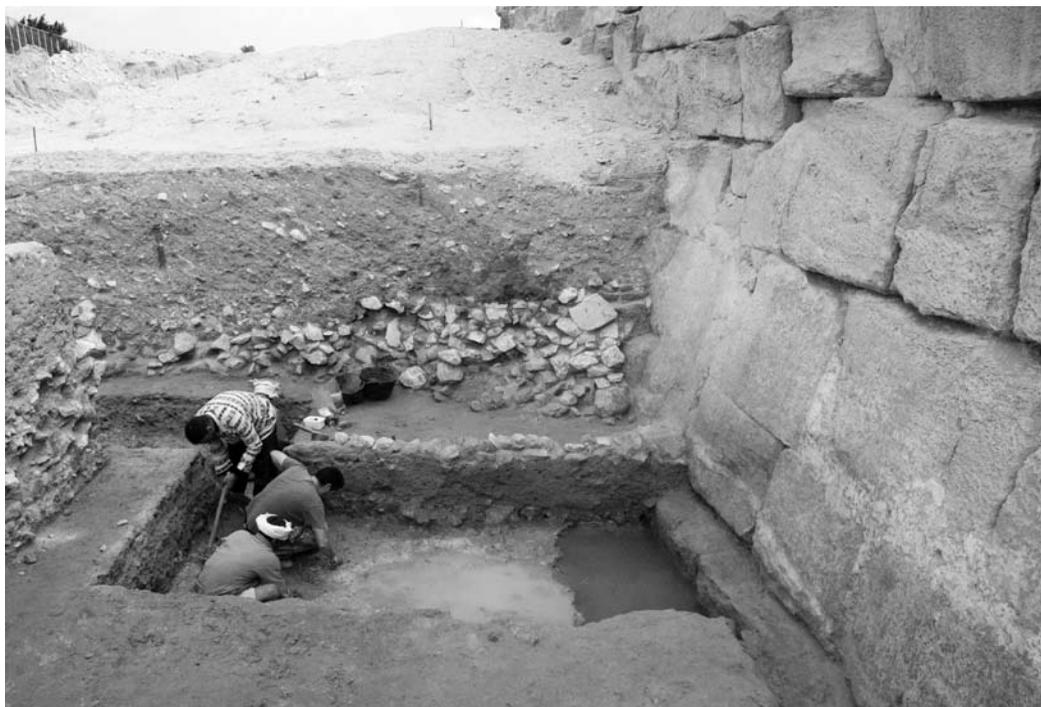
**Figure 8.** WCN, Trench 2 extension and deep probe. The foundation stones of the Wall of the Crow, far right, can be seen protruding from under the wall. The section shows the composition of Masons' Mound. Note crude limestone rubble wall running perpendicular to the Wall of the Crow. View to the east

In 2005 Derek Watson excavated Trench 2 (fig. 8) in order to trace the layering to the base of the Wall of the Crow (Watson 2005). In 2006 he extended Trench 2 to the west, opening a square, 6.0 m east–west  $\times$  5.6 m north–south, in which he found evidence of a series of limestone rubble walls built upon the Sand Separation Layer. Some ran parallel to the Wall of the Crow, others perpendicular, forming compartments. These were crude versions of the retaining and accretion walls that Egyptian builders used as temporary ramps and embankments for erecting large-stone structures. The evidence suggests, again, that Masons' Mound is the remains of such a ramp or embankment.

out toward the Wall of the Crow. Over the Lower Rubble Layer was a layer of gritty, rubbly sand, 28 to 35 cm thick. It is very possible that the builders dumped this sand to level out the Lower Rubble Layer so as to make an even bed for the ramp or embankment of Masons' Mound.

As they did with mastaba tombs and the Great Pyramid of Khufu, the builders prepared a low masonry foundation for the larger superstructure of the Wall of the Crow. The foundation slabs range from 36 to 45 cm thick and protrude from the bottom of the lowest course of stones by 35 to 40 cm (fig. 8). The tops of the foundation slabs on the northern side were 15.91 m to 15.82 m above sea level (asl). The builders laid them onto the Lower Rubble Layer, and partially into a shallow trench or cut into this layer, at 15.41 to 15.29 m asl. This compares to the value, 15.41 m asl, for the base of the foundation slab at the northeast corner of the Wall of the Crow.

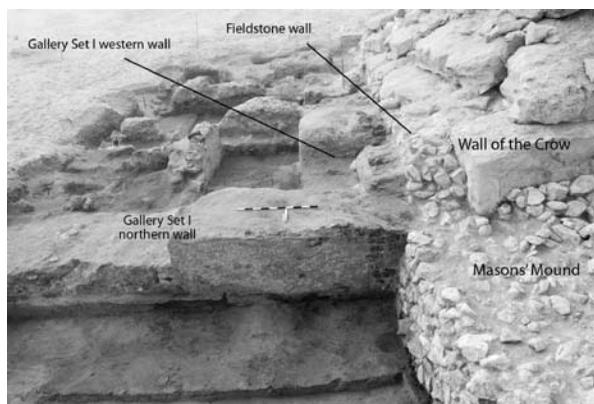
**Figure 10. Juncture of the Wall of the Crow, Gallery Set I northern and western walls, and Masons' Mound. View to the south**

Yeomans extended her trench westward at the end of the Wall of the Crow to clarify the relationship between the Wall of the Crow and Gallery Set I. In 2002 we learned that the eastern end of the Wall of the Crow was built up against the western wall of Gallery Set I. The corners of Gallery Set I, the Wall of the Crow, and Masons' Mound all meet here and would have touched. But when the builders placed the limestone blocks up against the western face of the gallery, they angled the end of the Wall of the Crow slightly west of north, leaving a thin, pie-slice gap, into which the fieldstone wall runs (figs. 10, 11).

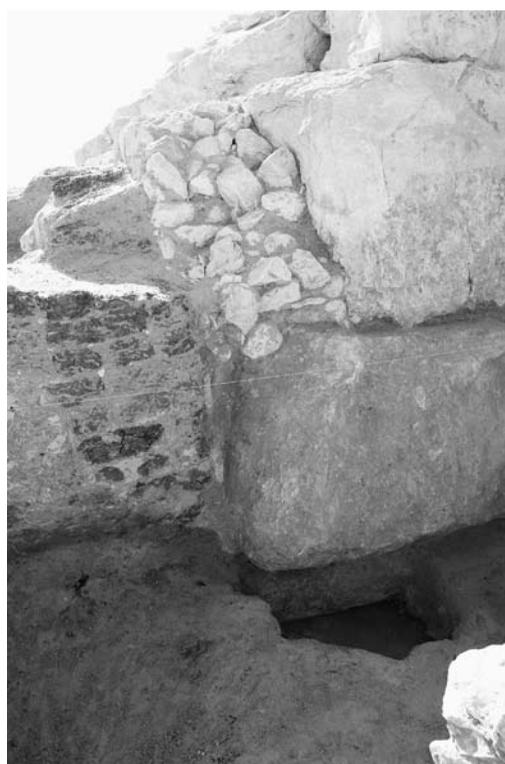
**Figure 11. WCNE juncture at the foundation of the Wall of the Crow. Note foundation slab beneath the corner stone of the Wall of the Crow. View to the southwest**

The actual corner stone of the Wall of the Crow was a very large block, 1.60 m east–west × 88 cm high. It sat on a thinner foundation slab, 43 to 44 cm thick, positioned in a foundation trench filled with smaller stones and sand. The large corner stone above it projected 20 or 30 cm farther out than the face of the foundation slab (fig. 11). This is the opposite of what Watson found in Trench 2, where the foundation slabs project about 35–40 cm from the face of the first course above. The difference lay in the fact that the masons dressed the lower courses of stone in Trench 2, but did not carry out this operation at the east end of the Wall of the Crow, leaving the wall unfinished. The bottom of the foundation slab was 69 cm lower than the base of the adjacent mudbrick walls of Gallery Set I. Here the bottom of the Wall of the Crow foundation is 15.41 m asl. This is within centimeters of the elevation at the bottom of the

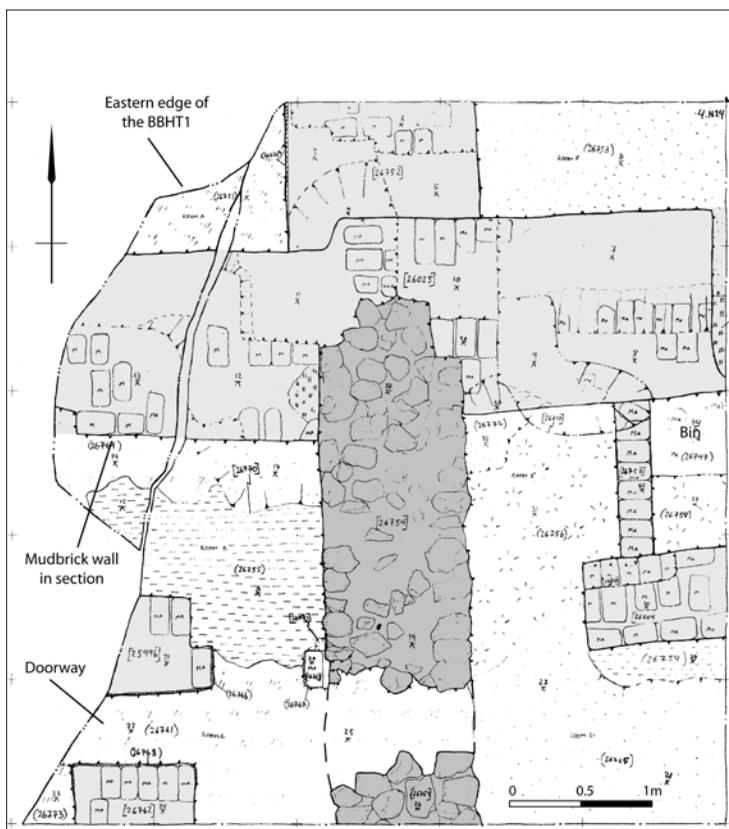
**Figure 13. BBHT1.  
Sq. 4.N24 excavations**

The wall, 1.25 m wide, runs east–west across the entire square, intersecting with another 1.25 m thick wall. The latter wall is slightly thinner south of the intersection, where it is built of limestone pieces (possibly the foundation for mudbrick). These two major walls formed four rectangular spaces, which may have been interior rooms. Features here include a bin and a doorway.

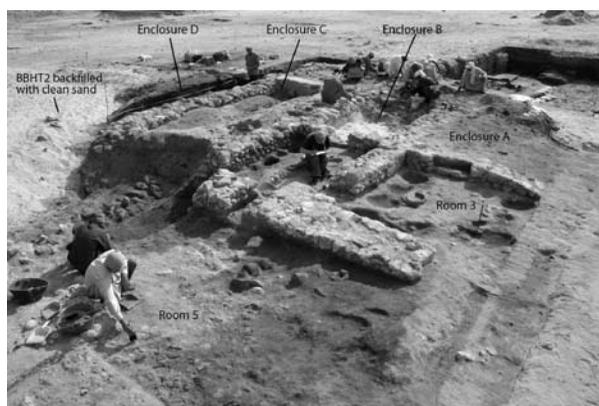
*Figure 14. BBHT2 bakeries. Note pot emplacements in Room 3, along bottoms of walls*

A large pottery vat, like those in the two bakeries we found in 1991 (Lehner 1992c), was in the southeast corner in a small room,

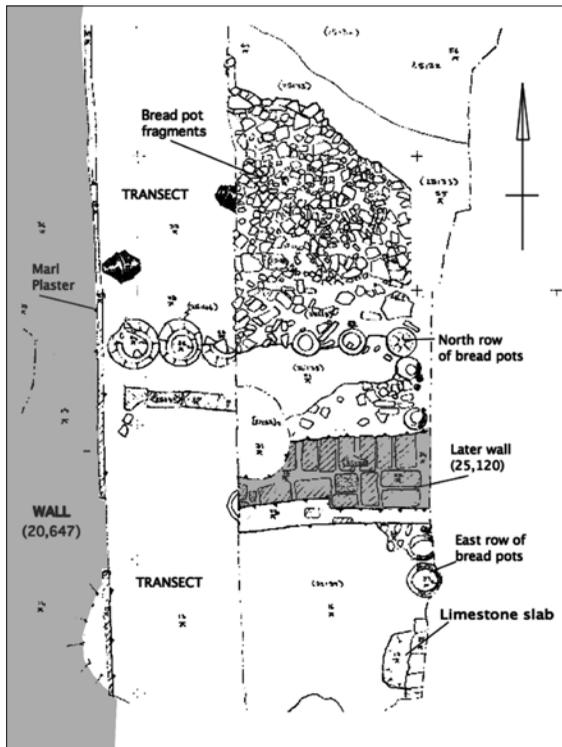
Figure 16. The EOG lower-phase bread-pot feature and later wall, from drawing GPMP 2006-662 by Mike House

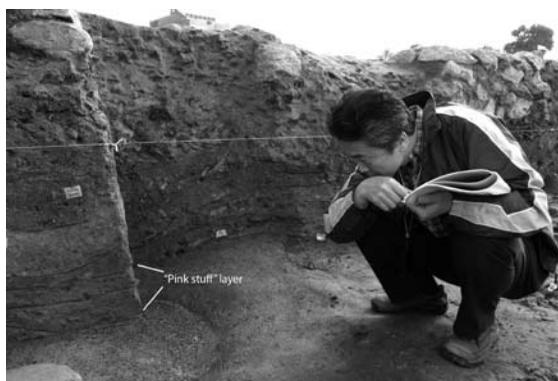
Figure 15. Nakal Izumi, leader of the XRF/XRD team, examines the “PS” layer in EOG prior to sampling the material for x-ray fluorescence/x-ray diffraction analysis. View to the southeast

The team found that the PS was a massive dump of soft waste from some pyrotechnic activity (fig. 15). It contained small pieces of faience and slag. At the northern end of the PS zone, House came upon a large round pit and excavated through seven or eight distinct PS layers with a combined thickness of 50 to 80 cm. He did not reach the bottom of the pit due to the high water table.

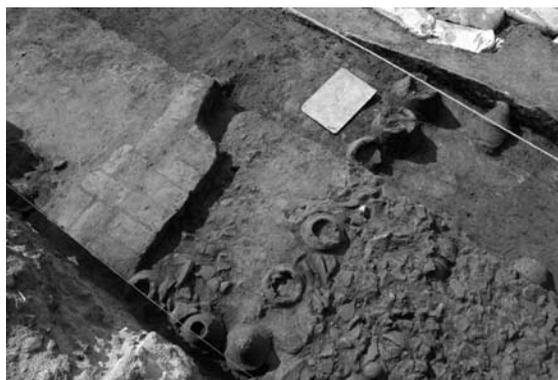
Figure 17. EOG, lower-phase sherd layer and bread pots in a line. View to the southwest

the eastern base of the main north–south wall. The excavations exposed a row of five bread pots turned upside down, resting on their rims. He excavated an east–west shallow trench, 1 m wide, through the lowest layers above the floor on which the bread pots rested.

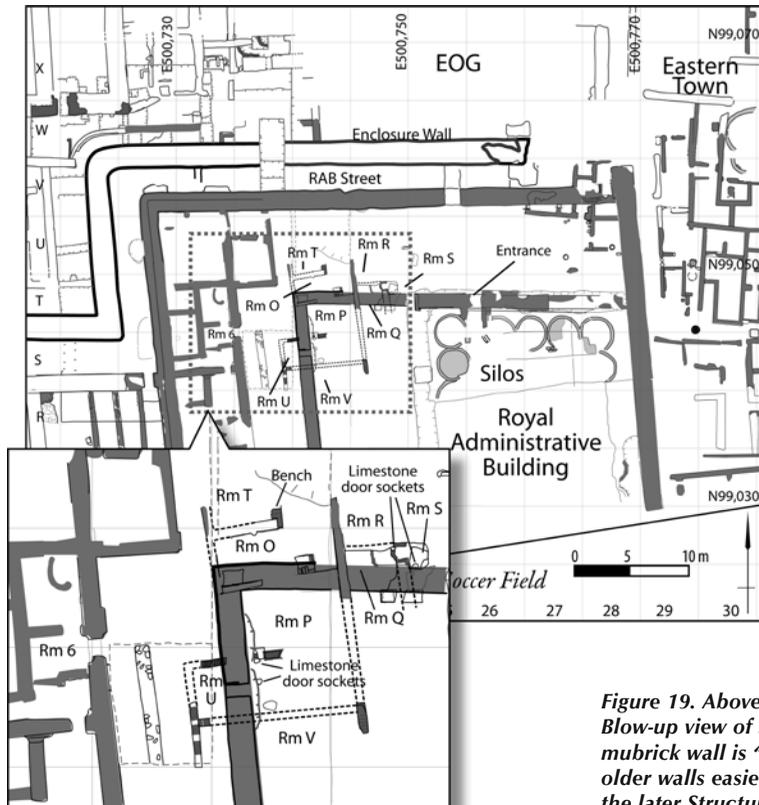
**Figure 19.** Above: Map of the RAB operations. Left: Blow-up view of Structural Complex 2 walls. A thick mubrick wall is “faded” to make the underlying, older walls easier to see. The thick wall belongs to the later Structural Complex 1

(Structural Complex 2), which ancient workers demolished and leveled in order to construct the later complex (Structural Complex 1), the greater RAB enclosure (Sadarangani 2005).

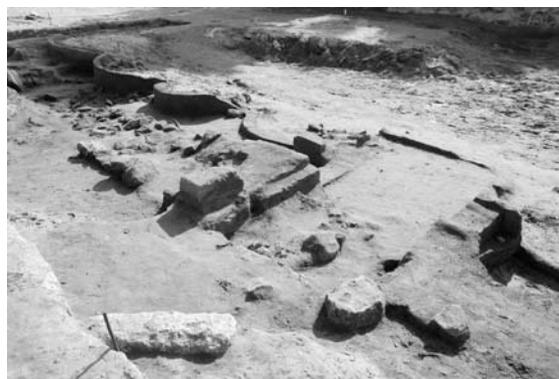
*Figure 20. The RAB silos and entry into the Silo Court. The dark sand in the background is backfill of the Sunken Court, saturated and moldy from ground water. View to the southeast*

except for a gap of 1.40 m in the northwest corner, which corresponds to a gap in the northern mudbrick wall. Along with two small north–south walls on either side, these openings create an entrance into the central portion of the compound (fig. 20).

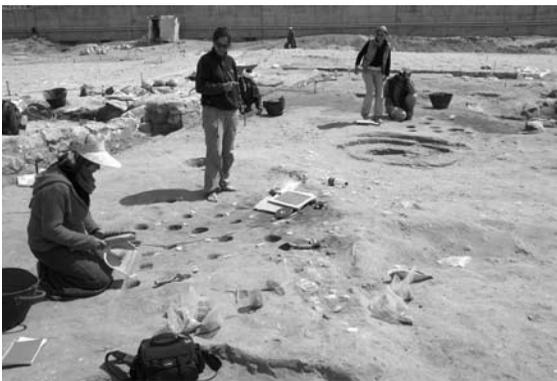
**Figure 21.** *Circular features in the RAB northern court. Note circular depressions in forefront of photo and circular pit farther east. View to the east*

The earliest occupation features of the northern courtyard included a roughly laid, sloping metalled surface of limestone gravel and a circular pit bordered with mudbrick. Two clusters of circular depressions flanked the pit, twenty-three on the west and eight on the east, along with a shallow, clay-lined pit (fig. 21). The diameters and depths of the western depressions could have accommodated the bases of small bread molds. The eastern depressions are more varied, with diameters and depths suitable as sockets for the bases of medium-sized bread molds. However, we found no evidence of burning, such as we might expect if these were baking pits.

The mudbrick-bordered, circular pit was in use longer than the pot emplacements and underwent several alterations. People filled the original pit with mudbrick and rebuilt the mudbrick border on top. During the final renovation they added a limestone border (three courses remain),

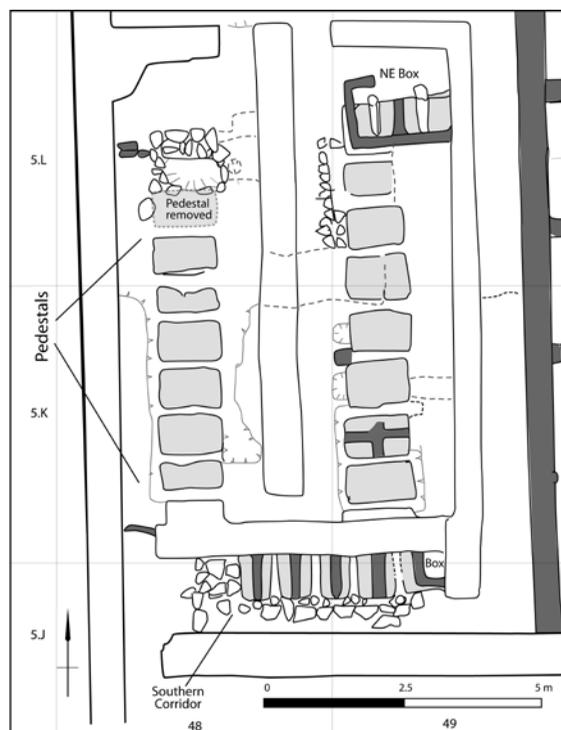
**Figure 22. Schematic plan of the PB after 2006–2007 excavations. An early phase of the building had eight pedestals in either row. The inhabitants took down the last northern two of the eastern row when they built the NE Box. Excavators in 1988–89 took down the remains of the second to the last on the northern end of the western row. The last on the north was modified with a stone-lined basin on its southern side**

In 2006 we found that the walls did indeed form compartments on pedestals. They stood at least 20 to 30 cm high on four pedestals, which were 56 to 64 cm high × 55 cm wide × 74 cm deep. A half pedestal in the east marked a total of four slots. The series ended in a narrow box, 41 cm wide, formed by an L-shaped single-brick partition wall built against an extension of the east wall of the PB.

The partitions created four compartments, each about 60 cm wide, formed over one of the slots between the pedestals. The widths of the slots are irregular because the sides of the pedestals are mostly unfinished. One slot,

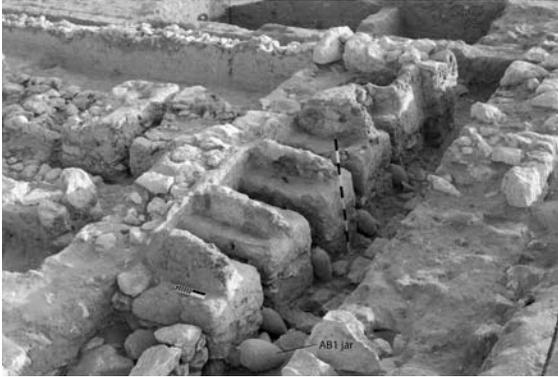
**Figure 23.** *The southern corridor of the Pedestal Building after 2006. View to the northeast*

At the base of the pedestals we found four complete red pottery jars still in place, leaning inward against the pedestals just in front of the slots (figs. 23–24). Commonly called “beer jars,” (our type AB4, see Wodzińska 2007: 296–97), these porous, crude, handmade jars are the second

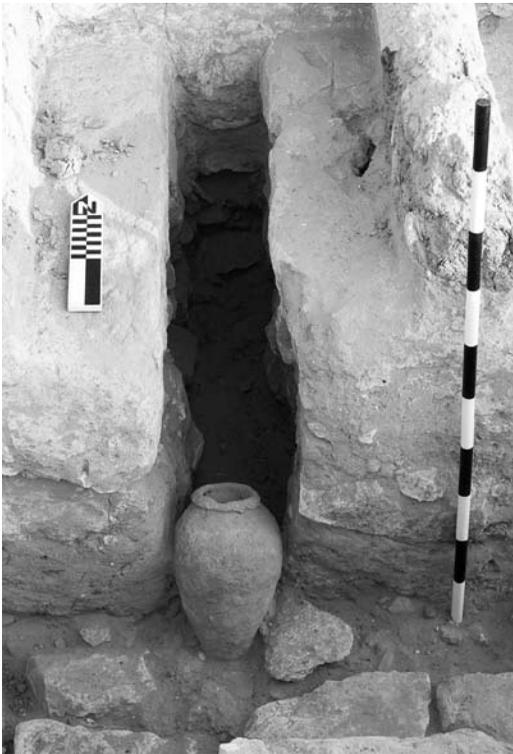
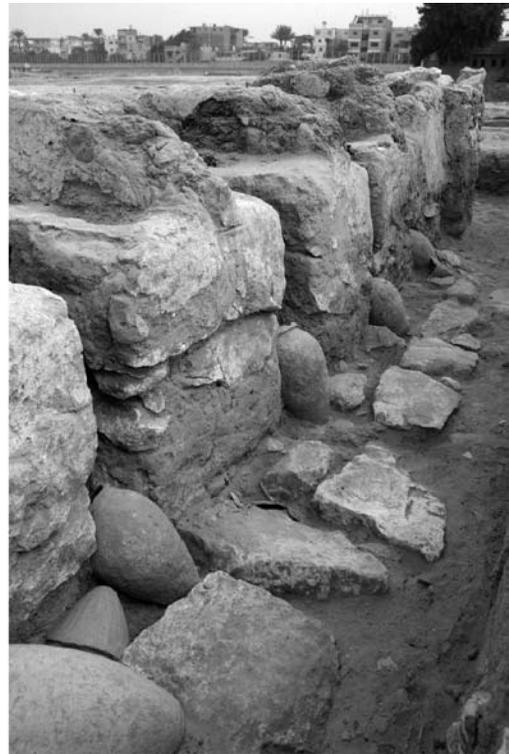
**Figure 24.** *Jar in place against the opening of a slot between pedestals (left), and jars leaning into slots down the pedestal series in the southern corridor of the Pedestal Building (right). The sides of the slots are not rendered with plaster, leaving exposed the irregular limestone and clay fabric*

On the floor, the jar bottoms stood in the fill of a crude channel, 12 to 20 cm wide, with a border of limestone pieces. In 1988–89 we found similar channels along the bases of

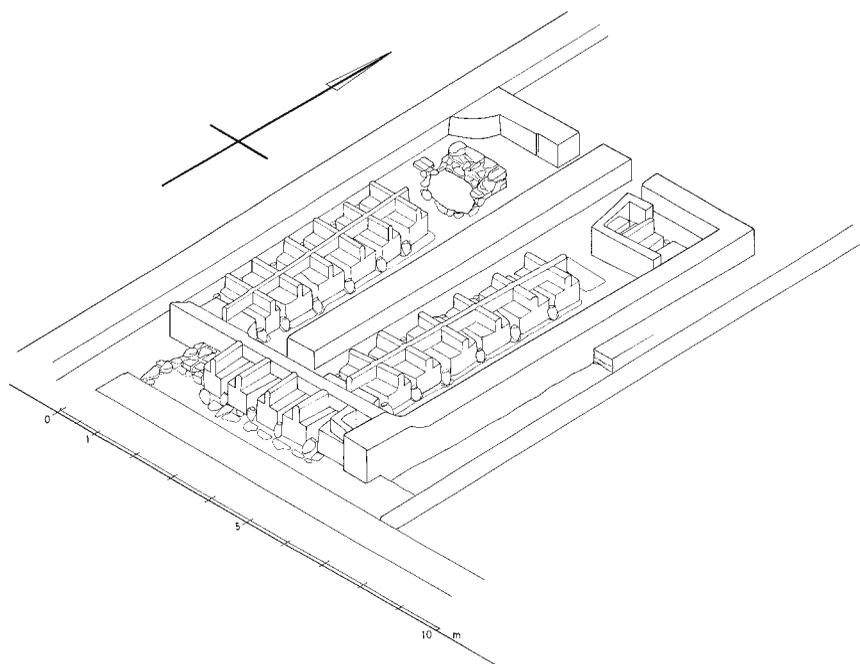
**Figure 25. Reconstruction of the Pedestal Building with partition walls forming compartments over the slots and pottery jars at the base of each slot**

We are considering several hypotheses about the purpose and function of this ensemble. The compartments appear to have been for storage, off the ground, with ventilation underneath provided by the spaces between the pedestals. The upright jars may have caught a substance dripping from storage containers. Or, if filled with water, the jars might have helped to keep the compartments cool and moist by the evaporation of the water. The function of the pedestals may have been related to the activities in the structures immediately north of the PB.

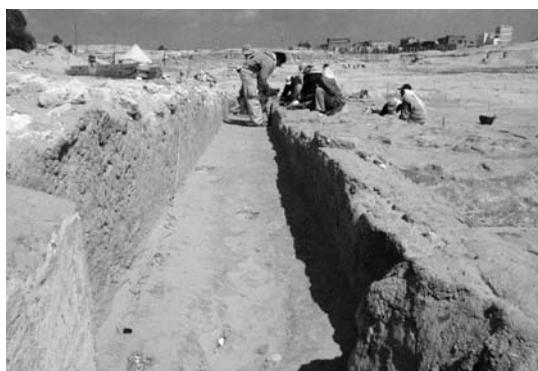
*Figure 26. The corridor along the western side of Area AA-FS following excavations by the students of the 2007 field school. View to the north*

On the north side of the PB is an east–west corridor with an opening on the north leading into another structure (Lehner 1992c: 57, fig. 1). Along the west side of this northern building the field-school students excavated a corridor, 90 cm wide (figs. 26–27). Its west side was bounded by a north–south limestone wall, which was an extension of the west wall of the PB. The narrow corridor ran from a doorway, 68 cm wide, at the western end of the corridor between the PB and the Oven Room. The western face of the corridor’s eastern wall was painted black along the base. The students excavated down to a loamy mud floor, the same level as the floor of the PB, 40 cm higher than the floors in the northern building.

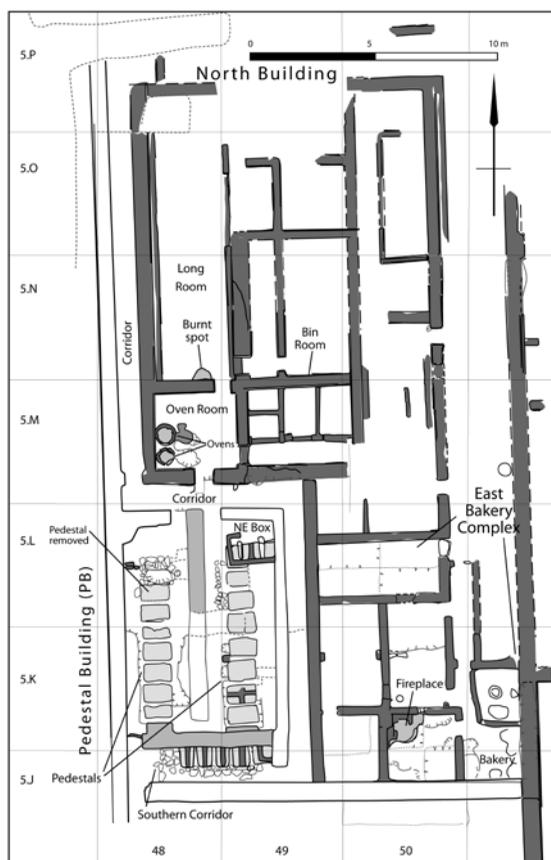
*Figure 27. Schematic plan of the Pedestal Building and the mudbrick building to the north and east. The Long Room, Oven Room, Bin Room, and eastern bakeries were excavated in 2006–2007*

To the east of the corridor we excavated a series of rooms in the North Building, north and east of the PB (fig. 27). We ascertained the general shape and dimensions of the North Building by plotting the walls that show in the ruin surface (the “mud mass”) on the northeast, where we have not yet excavated, and by combining the plan of these walls with the ruins on the southwest,

This season we excavated a series of rooms that is a southerly extension of the eastern strip of the northern building (fig. 27). On the south this room complex is bounded by an east–west limestone wall that is also the southern boundary of the PB. A north–south mudbrick wall on the east side separated the complex from House Unit 1 (see below). So far we have found no access or doorway through this major north–south wall, so the PB and northern complex appear to have been strictly separated from the Western Town. The eastern arrangement appears to have been entered through a broad corridor, slightly over 2.5 m wide, running along the east side of the complex.

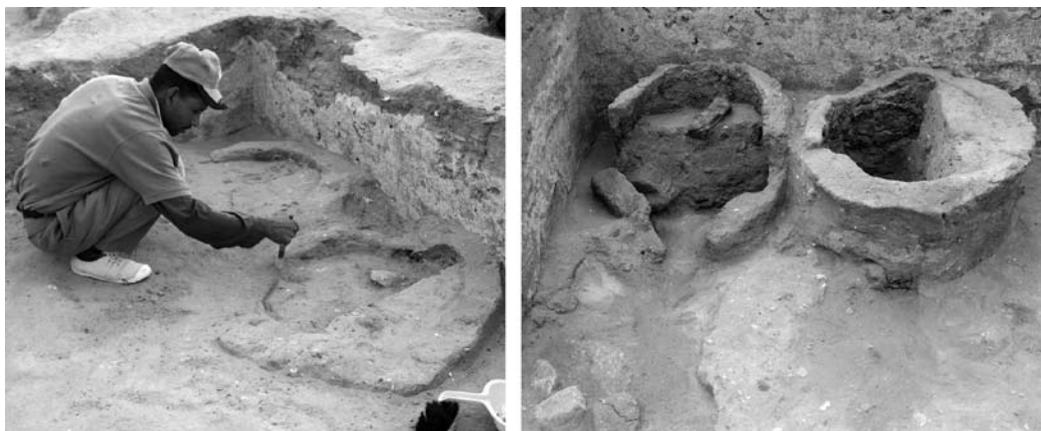
*Figure 28. Excavation of the ovens (left) in 2006, and the ovens after excavation (right). View to the southwest*

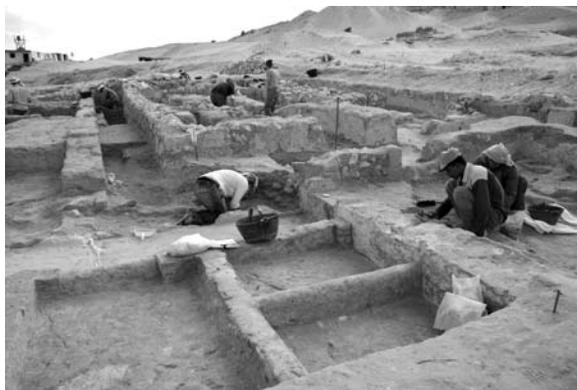
*Figure 29. Oven Room and Bin Room. View to the west*

In the first chamber immediately north of the PB, the Oven Room, Banu Aydmoglugil excavated two ovens, about 70 × 85 (south oven) and 92 × 94 cm (north oven) in diameter (fig. 29). The oven walls were a single-brick (10–12 cm) thick. Irregular depressions in the floor at the eastern bases of the ovens seem to have been part of the assembly. Whitish wood ash filled the bottom interior of the ovens.

To the east of the Oven Room, we excavated a chamber, 2.8 m × 1.98 m, which contained three rectangular bins of approximately equal size that divided the northern part of the chamber (figs. 29–30). A corridor ran along the bins on the south. Low round-topped walls, about 25 cm high, partitioned the bins from one another and from the corridor. Before the workers made the partition walls, they plastered the inner southern and eastern faces of the main walls of the room, facing into the room, with a pink gypsum plaster.

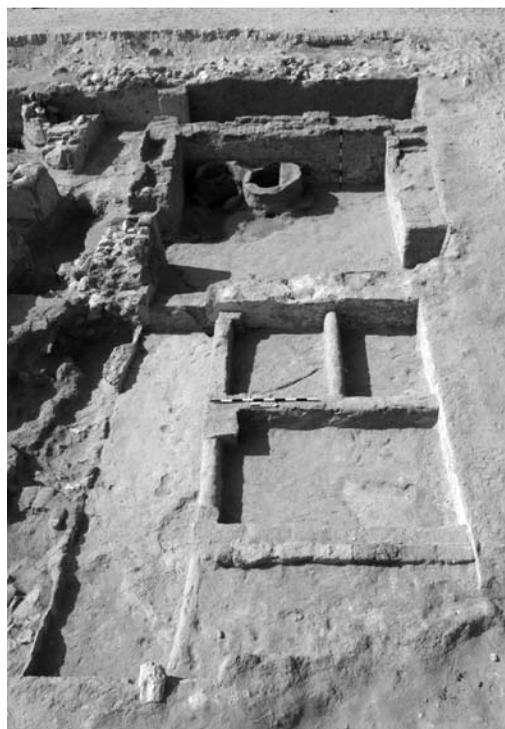
*Figure 30. Excavations north of the Pedestal Building in 2006. The Oven Room is to right, the Bin Room to the left. The Pedestal Building is on the right in the background. View to the southwest*

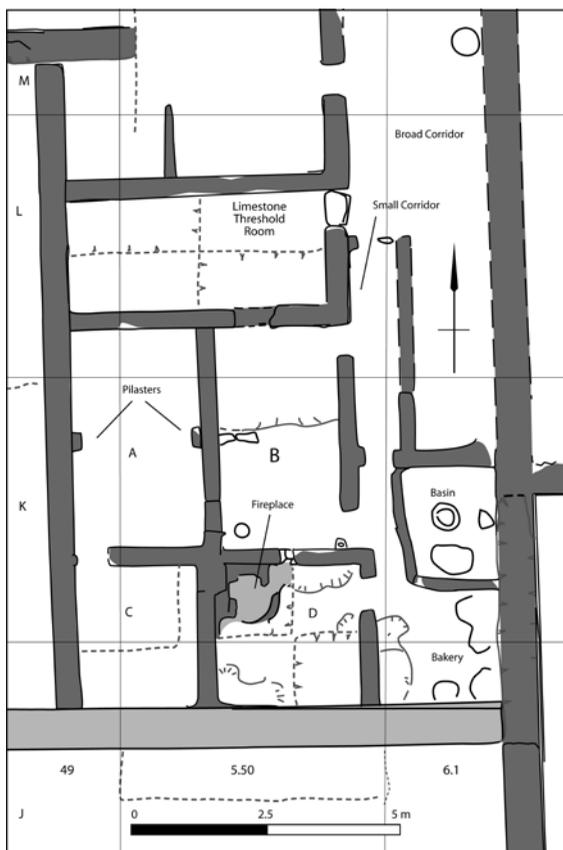
Figure 31. Map of the East Bakery Complex in Area AA

Just outside the doorway of the Limestone Threshold Room two large bread pots lay on the floor, obscuring evidence of a narrow doorway and corridor leading south into a series of small rooms (fig. 31). At the end of the season, after the excavations had ceased, we found a narrow, single-brick jamb extending east from the exterior wall of the Limestone Threshold Room. Several centimeters farther east, stones set into the floor may mark the threshold of an entrance into a narrow corridor. A portion of the eastern wall is preserved running north from the Basin Room and forming a corridor about 1 m wide. If this corridor had continued all the way to the jamb it would have restricted access to these rooms, which appear to have been a baking complex.

At the south end of the narrow corridor a doorway, 58 cm wide, opened into the Basin and Bakery Room, 2.40 × 4.45 m (fig. 31). In the northeast corner a low, round-topped rim, a single brick wide, enclosed a basin 2.20 × 1.90 m. The basin had a noticeable and probably intentional oval-shaped dip to the south, lined with silt. A silt-lined hole in the center of the basin, 50 cm diameter at the top and 30 cm in diameter at bottom, could have accommodated one of the small vats, about 42 cm diameter, such as we have found embedded in floors elsewhere on the site.

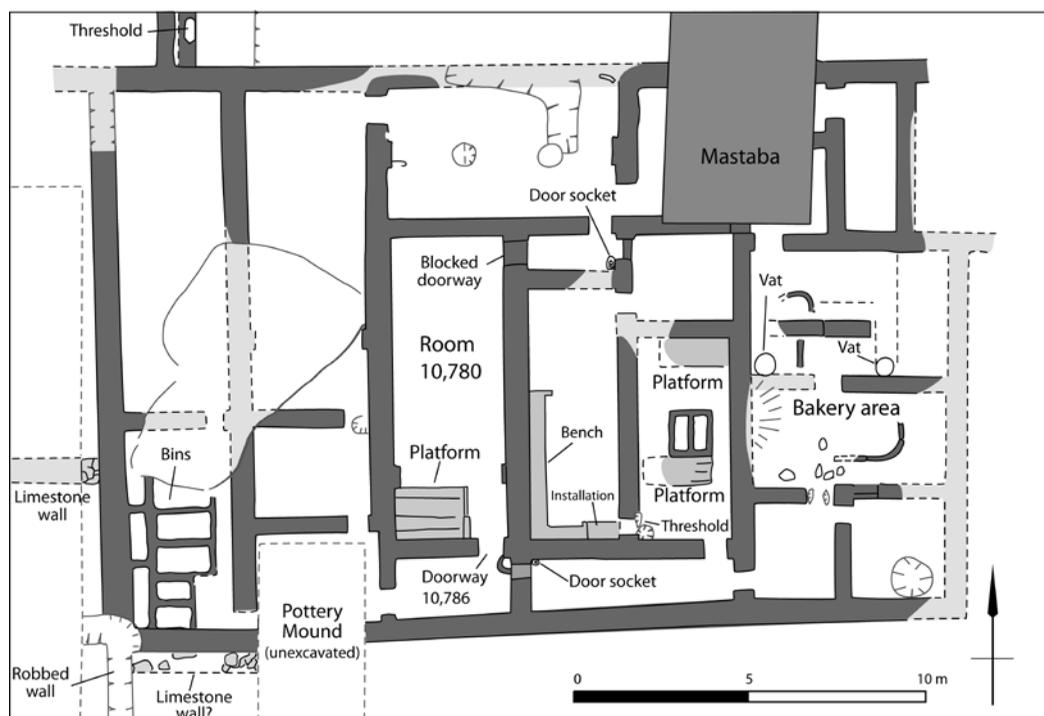
Figure 32. Map of House Unit 1. After a field drawing by Yukinori Kawae

After seasons 2004 and 2005 we had not yet defined the western and northern boundaries of House Unit 1. In 2006 we determined what are most probably the outer walls (fig. 32). If these were indeed the bounding walls, House Unit 1 spanned approximately 25 m east–west × 16 m north–south, an area of 400 m<sup>2</sup>. We also determined that House Unit 1 was built before the

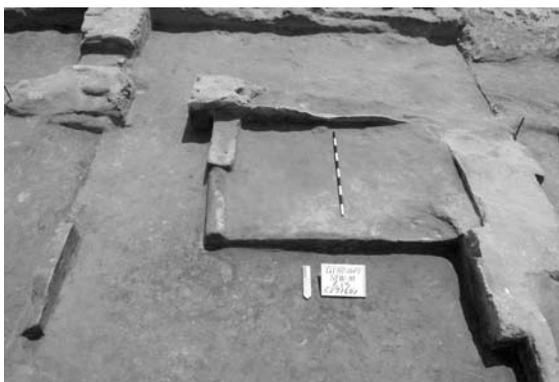
Figure 33. Bed platform in central room of House Unit 1. View to the south

The room may have been the main hall of the house with a bedchamber for the proprietor or senior resident. Just in front of the platform to the north we found a pile of fragments of molded marl clay with red-painted surfaces. While these could derive from the walls and roof of the room, the fact that this concentration lay immediately north of the bed platform suggests the fragments could derive from decoration of the niche enclosing the bed.

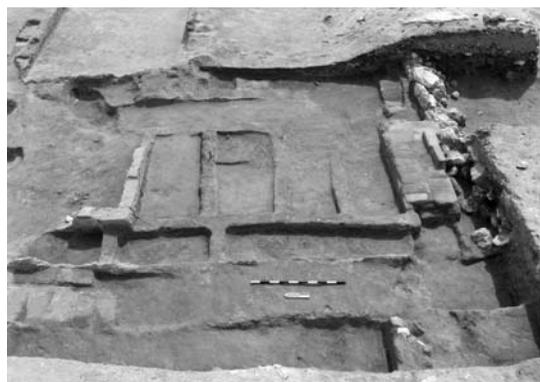
Figure 34. House Unit 1 bins and, to the right, Pottery Mound section. View to the east

In 2007 we also excavated a peculiar series of six bins in a room, 5.86 m about 2.5 m, in the southwest corner of House Unit 1 (fig. 34). A narrow corridor, 50 cm wide, passed along the east side of the bins. These had been re-plastered and painted at least once. The partitions are preserved only 6 to 31 cm high.
