## KERKENES DAĞ PROJECT

Scott Branting

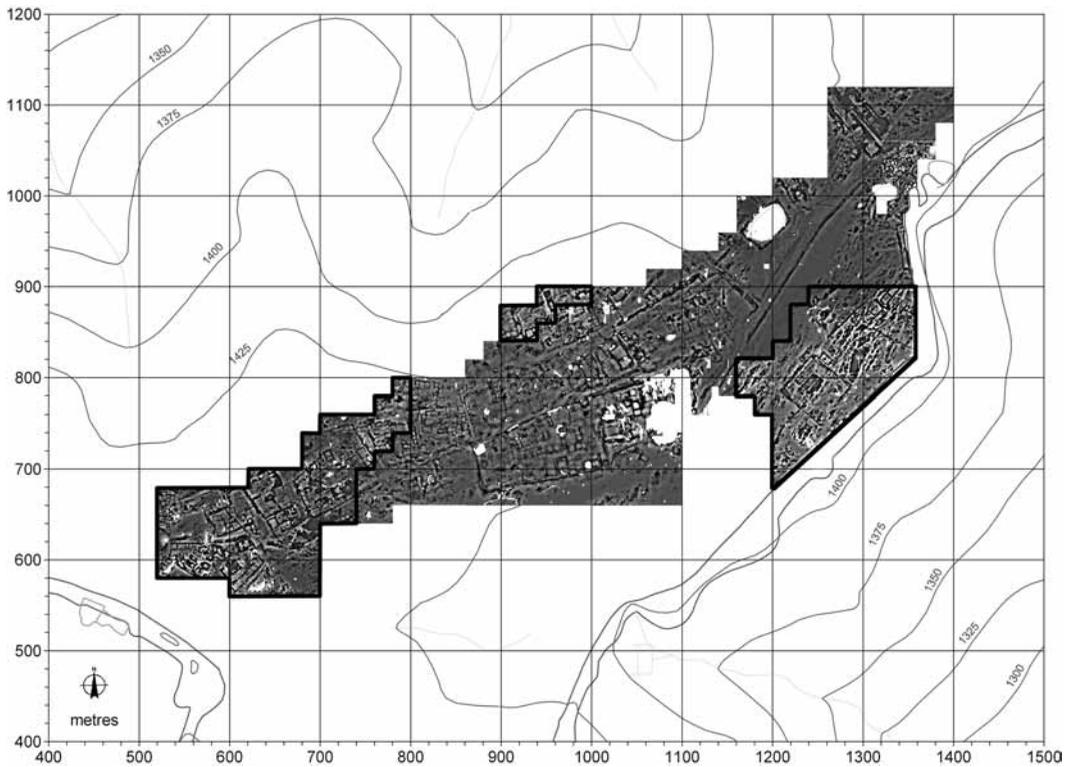
Figure 2. The resistivity survey data collected between 2007 and 2011 on the southern ridge of the city. The areas covered in 2010 are outlined in black

Four areas of resistivity survey covering a total of 69,200 sq m (6.9 ha) were completed in May of 2010. Three of these areas are in the southern portion of the city (fig. 2). The first area, to the east of the Palatial Complex and just south of the Cappadocia Gate, extends to the south the area surveyed in 2009 (see *2009-2010 Annual Report*, p. 66). The second area, to the north of the Palatial Complex, extends the western extent of the 2009 survey. The third area, between the Palatial Complex and the Göz Baba Gate, extends the western extent of the 2007 and 2008 surveys (see *2007-2008 Annual Report*, pp. 86-87, and *2008-2009 Annual Report*, pp. 88-89). In addition, a fourth small area was surveyed around the “Temple” in the lower west-central part of the city in preparation for the excavation undertaken there in June and July.

All told, the past four seasons have surveyed 18 ha of the high southern ridge between the Kale, the Cappadocia Gate, and the Göz Baba Gate. This includes the entire Palatial Complex and many of the urban blocks in its vicinity. A good portion of the urban blocks facing the street running between the Cappadocia Gate and the Göz Baba Gate have also now been

surveyed, as well as the open areas in front of the Palatial Complex and the Cappadocia Gate. This includes the urban block and associated structures on a small rise just inside the city wall to the south of the Cappadocia Gate, which may have had some special relationship to the Palatial Complex, given their isolated position opposite it in a wide open area. It also includes the narrow structures and water storage ponds surveyed last year opposite the Cappadocia Gate. The characteristics noted in the urban blocks across this area are varied. In the Palatial Complex and adjacent urban blocks there do seem to be more large structures, perhaps with a public or elite function. In more distant urban blocks, back toward the Göz Baba Gate, the buildings within the urban blocks are more in keeping with the character of urban blocks seen elsewhere in the city. Of course the uses to which these more typical buildings were put remains unknown. This area may have been filled with workshops and storerooms in the long narrow rows of rooms seen throughout the area, and interspersed with residences for craft specialists and others linked to the palace. While the resistivity survey provides us with knowledge of the forms of the structures, their functions remain a mystery. Just beyond the westernmost extent of this survey area is a large and likely important urban block just inside the Göz Baba Gate. Survey here in future years may well change interpretations of the urban blocks in its vicinity.

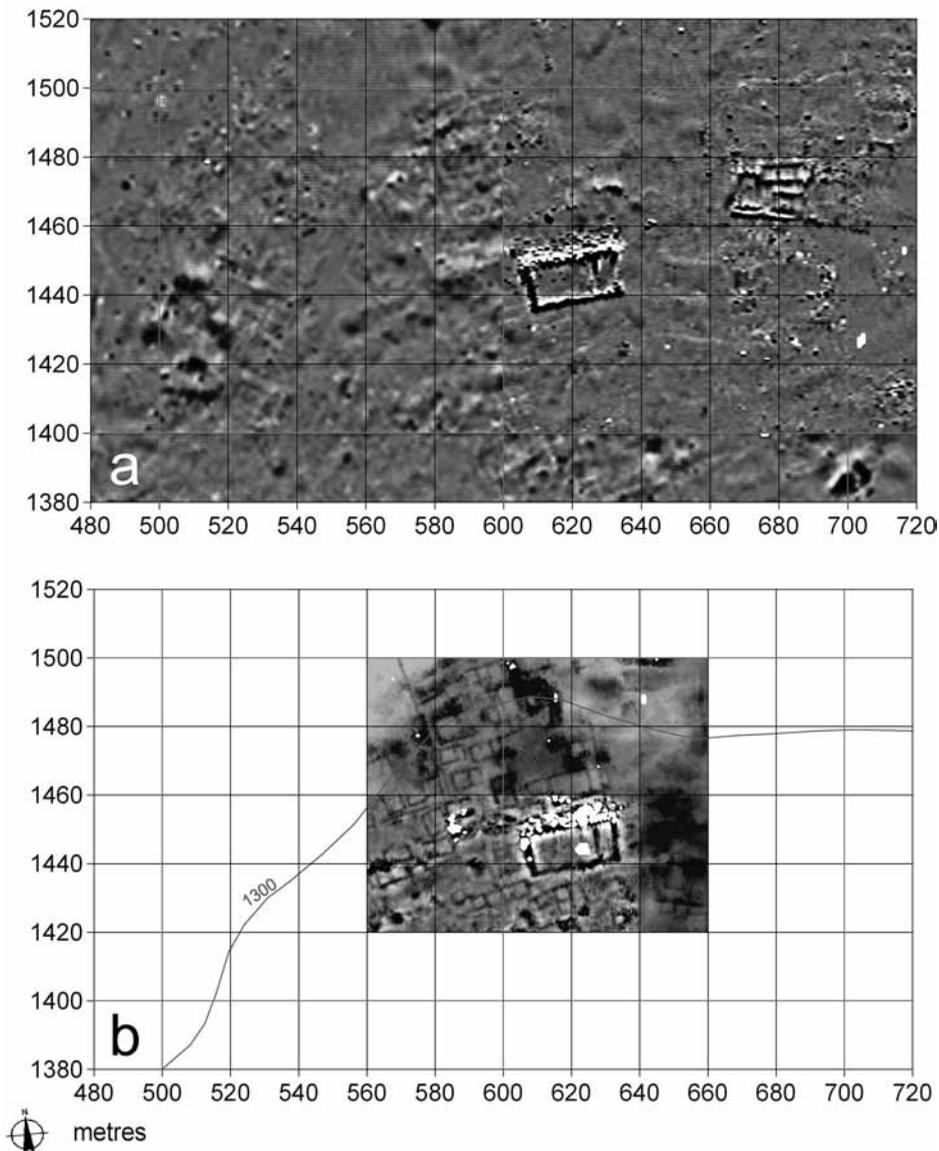
Figure 3. The results of the earlier magnetometry survey (a) and the resistivity survey (b) around the “Temple”

On the slopes to the west of the central part of the city, a small area of resistivity survey revealed a range of buildings around a large burnt hall (fig. 3). This impressive structure was clearly visible in the magnetometry data, yet the buildings in the urban blocks around it were very difficult to discern. Surveying this area in May allowed better decisions to be made as to

where to place the trenches excavated in June and July, including identifying a small square building behind the large hall that was a focus of the excavations.

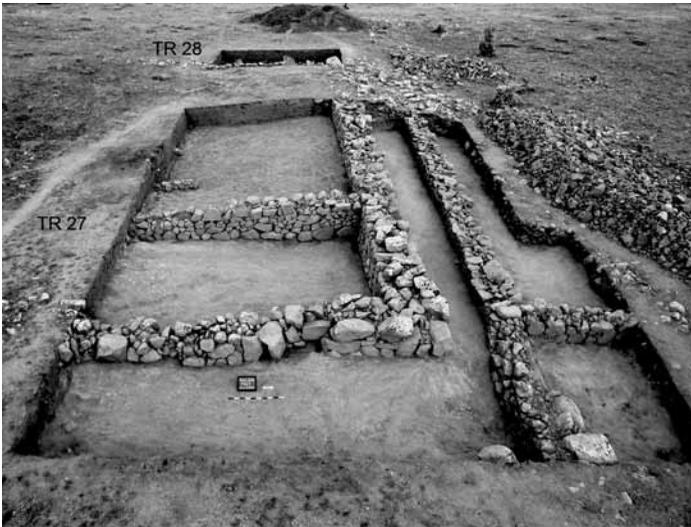
Figure 4. Photograph of Trenches TR27 and TR28 after excavation

Using the results of the geophysical surveys, trenches TR27 and TR28 were situated so as to uncover precisely half of a large two-roomed hall (Structure A) and a quarter of a square building behind it (Structure B) (figs. 4 and 5). Structure A, measuring 26.5 x 12.5 m, is one of the largest buildings so far seen at Kerkenes Dağ. Parallels for similar free-standing halls on this scale at Kerkenes Dağ are found within the Palatial Complex, in an adjacent urban block

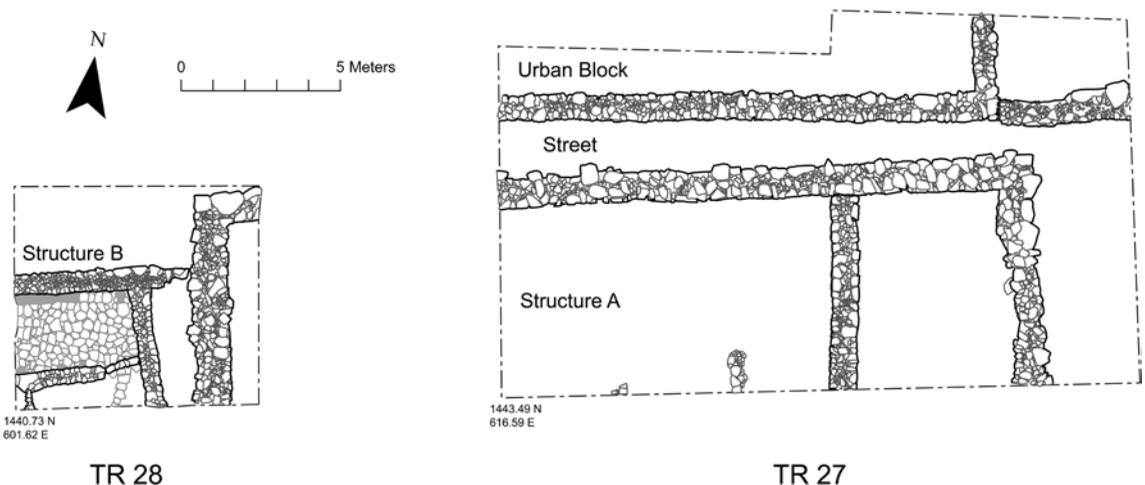
Figure 5. Plans of trenches TR27 and TR28

Trench TR27 exposed not only Structure A but also an area in front of the building, a narrow alleyway running along its northern side, and the wall of the adjacent urban block to the north. This expanded area allowed a majority of the stone collapse from the structure to be examined for any evidence of decoration or inscription that may have once been on or in the building. The excavations, however, revealed no such finds. The meter-wide foundation wall terracing the northern side of Structure A was preserved up to 1.4 m, but erosion over the past two millennia had washed away nearly all evidence of the floors, installations, and superstructure. Scattered nails and some charcoal were all that remained in the area, evidence of the large wooden superstructure and presumed thatch roof. Given the level of erosion in this area, excavations in TR27 were stopped after exposing half of the anteroom

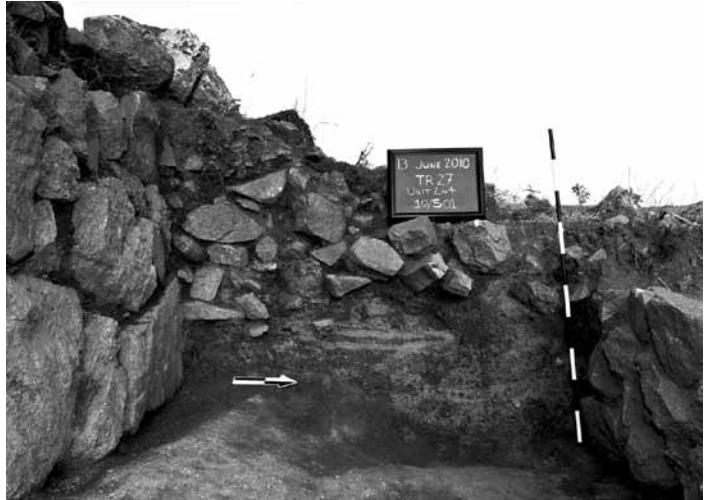
Figure 6. Section in trench TR27 bisecting the alleyway running to the north of Structure A

and over a quarter of the large internal room. One benefit of this destruction is that the collapse of the building had very effectively sealed the surface of the alleyway alongside it and prevented any erosion. The alley was unpaved and had clear evidence of layering and soil formation similar to streets excavated elsewhere in the city (fig. 6). Soil and micromorphological samples were collected from this alleyway for analysis at Cambridge University as part of an ongoing study of transportation in the city.

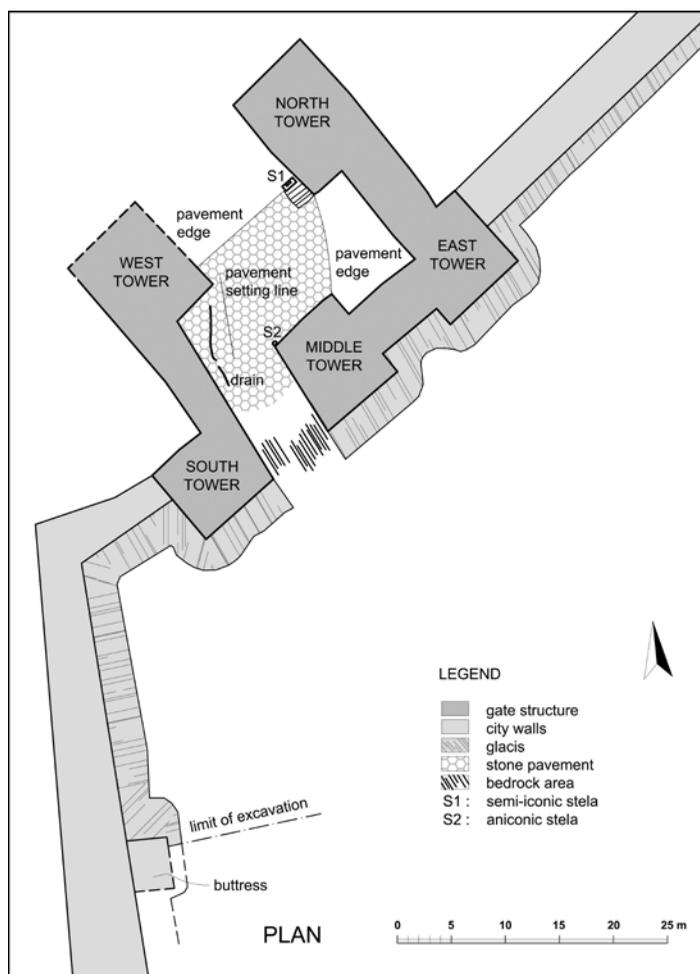
Figure 13. Plan of the Cappadocia Gate that incorporates the results of this year's excavations

Excavation resumed within the Cappadocia Gate in the later part of the 2010 summer season (figs. 13 and 14). The remainder of the gate passage was cleared to a point in line with the platform upon which the semi-ionic stela had been found. Here a line of large threshold stones were uncovered at the edge of the paving, spanning much of the width of the gate passage. An iron band, similar to those found in the entranceway to the Palatial Complex, was also found here as clear evidence of the doorway to which the threshold belonged. Clearance inside this doorway and in the area between the North and West Towers was left for 2011.

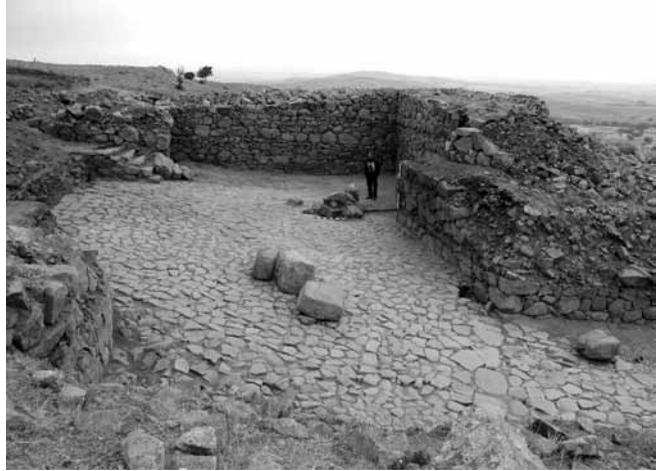
Figure 14. The extents of the Cappadocia Gate passage so far exposed and the full gate chamber

While this work was ongoing the remainder of the gate chamber was also cleared of collapse. This left the original walls of the chamber standing in places over 4 m high. The structural integrity of these walls had been compromised when the horizontal timbers, originally set into the faces of the walls at roughly 1 m vertical intervals and covered with plaster, were destroyed during the intense burning of the gate. Smaller stones from the core of the wall slid over time into the ca. 25 cm gaps left by the burnt beams, and this makeshift fill has supported the walls after clearance. However, the overall structural integrity of the walls is suspect. This was demonstrated all too clearly when a portion of the wall of the Middle Tower collapsed during the heavy rains that brought the season to a close. Restoration work within the Cappadocia Gate will make these walls more stable.

The stone paving that was uncovered within the gate passage extended well into the gate chamber. It had been laid up to a line running from the southern corner of the North Tower down to the northern corner of the Middle Tower. The pavement clearly was meant to end here, with the dirt floor in the rest of the gate chamber pocked by the heavy stones that fell from the gate during its destruction and collapse. On this dirt surface a second victim of the destruction of the city was found (fig. 15). This skeleton, like the first one uncovered in the gate passage last year, was apparently killed by the collapsing stones and beams of the gate. No objects were discovered with either body. While both individuals were found in the gate, there is some distance between the locations of their bodies. There is no evidence that they were together. However, how they came to be in the gate during its destruction still remains a mystery. This individual's body was so badly crushed beneath the falling stones that the position is difficult to discern. The heavy rains that brought down the wall of the Middle Tower in the last days of the season made lifting the skeleton this year impossible. It was covered and reburied awaiting full excavation and analysis in 2011.

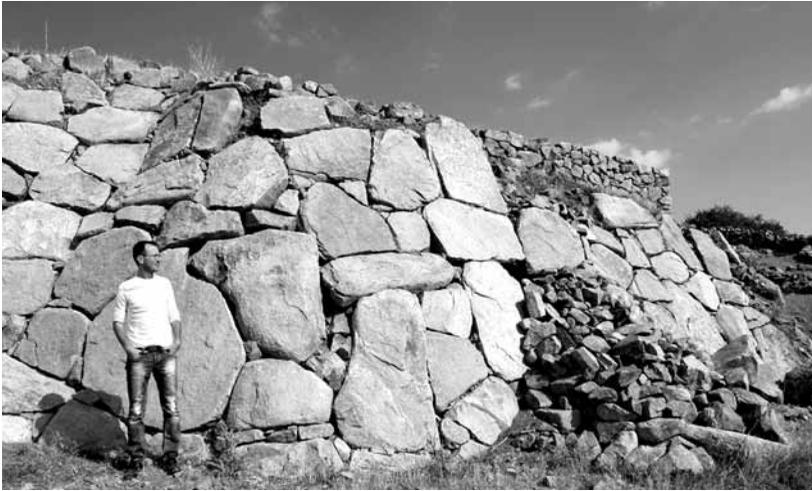
*Figure 16. The Cappadocia Gate glacis before the start of restoration work*

While excavations continued inside the Cappadocia Gate, the start of an extensive program of conservation and restoration on the outside of the gate commenced (fig. 16). The work has been the subject of architectural and engineering studies for the past several years. It was supervised by Nilüfer Baturayoğlu Yöney of Istanbul Technical University and undertaken by Erkan Kambeck and five master stone masons from Manisa. Heavy machinery generously provided by the Sorgun District governor and the Sorgun mayor allowed the masons to remove and replace several of the large granite glacis stones along a sizable stretch of wall as

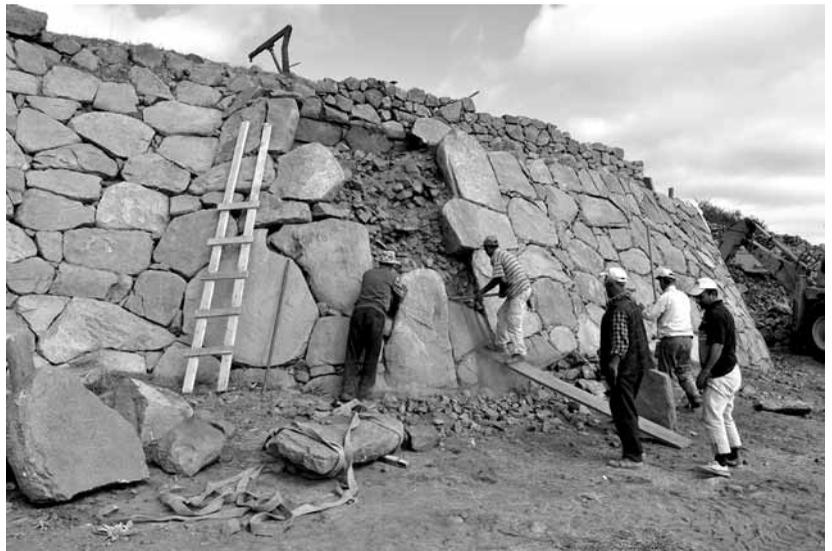
*Figure 17. Reconstruction of the Cappadocia Gate glacis in progress*

well as shore up the loose rubble core behind the glacis (fig. 17). Once the base was stabilized, the glacis was reconstructed back to its original height, all the way up to the face of the outer wall of the gate. The wall itself was rebuilt several courses above this point (fig. 18). It is expected that this reworked section will help to stabilize not only the glacis but also the structural walls of the gate. At the same time, it provides an extremely impressive vision of what the city wall and gates would have looked like during the life of the city.

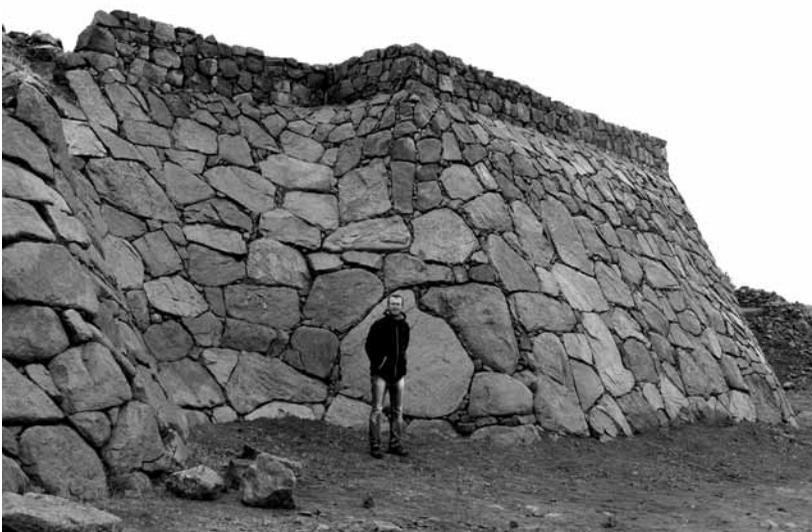
*Figure 18. Restored section of the Cappadocia Gate glacis and wall*
