EPIGRAPHIC SURVEY

On April 15, 2005, the Oriental Institute's Epigraphic Survey completed its eighty-first, six-month field season in Luxor, Egypt. What follows is the report on our activities at Medinet Habu Temple and Luxor Temple from October 15, 2004 through April 15, 2005.

Medinet Habu Small Amun Temple: Epigraphic Documentation

Luxor Temple: Luxor Fragment Project

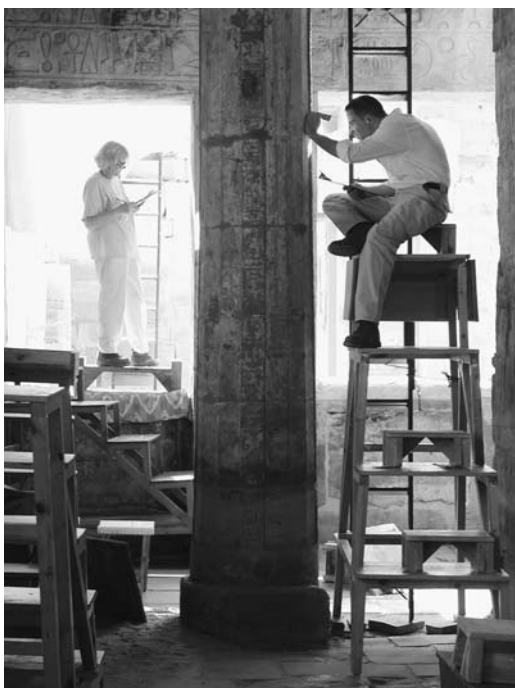
Figure 3. Epigraphic copying at the small Amun temple, Medinet Habu; artist Margaret De Jong and epigrapher J. Brett McClain. Photo by Ray Johnson

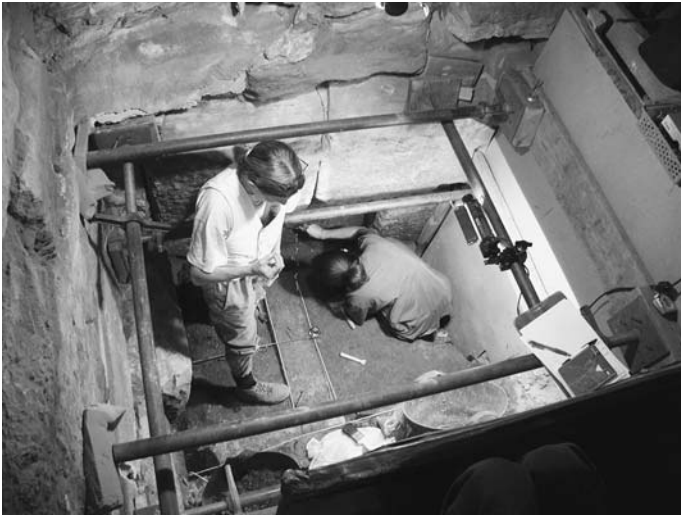
Figure 7. Recording of excavated footing of the naos in the Naos Room, small Amun temple, Medinet Habu by Lisa Giddy and Tina Di Cerbo. Photo by Ray Johnson

2,000 years. Archaeologist Lisa Giddy assisted by Egyptologist Tina Di Cerbo carefully excavated and recorded the subsided foundations of the naos in preparation for a new foundation and restoration of the stone floor in that area. They found eight carefully laid courses of small, sometimes reused, sandstone slabs (two of them Coptic) and baked brick going down almost a meter.

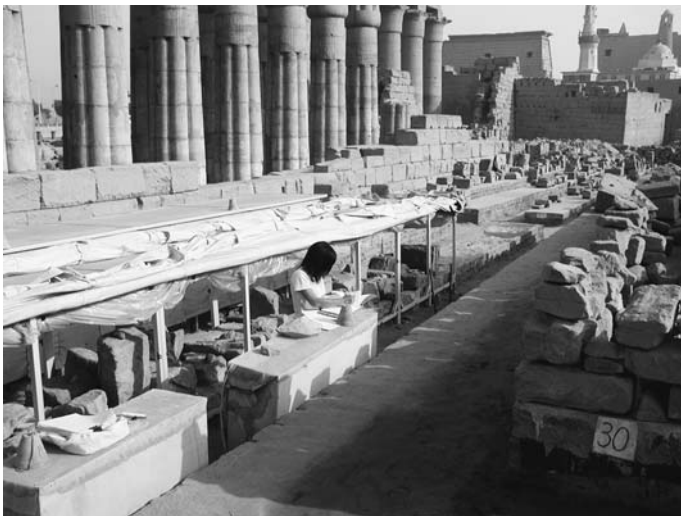
Figure 8. Hiroko Kariya condition-surveying deteriorating decorated sandstone wall fragments being consolidated. Southern blockyard treatment area, Luxor Temple. Photo by Ray Johnson

All of the inscribed sandstone fragments treated in previous seasons were condition surveyed and recorded by Hiroko, and she carried out three phases of treatment during this season on 161 fragments total. All the fragments were treated with Wacker BS OH 100 (ethyl silicate), and were examined and recorded before and after the treatment. Hiroko coordinated two phases of treatment of the large blocks of Amenhotep III in the southeastern blockyard; five during the first phase and ten during the second. These blocks were too large to move to the treatment area and were treated on their mastaba platforms *in situ*.

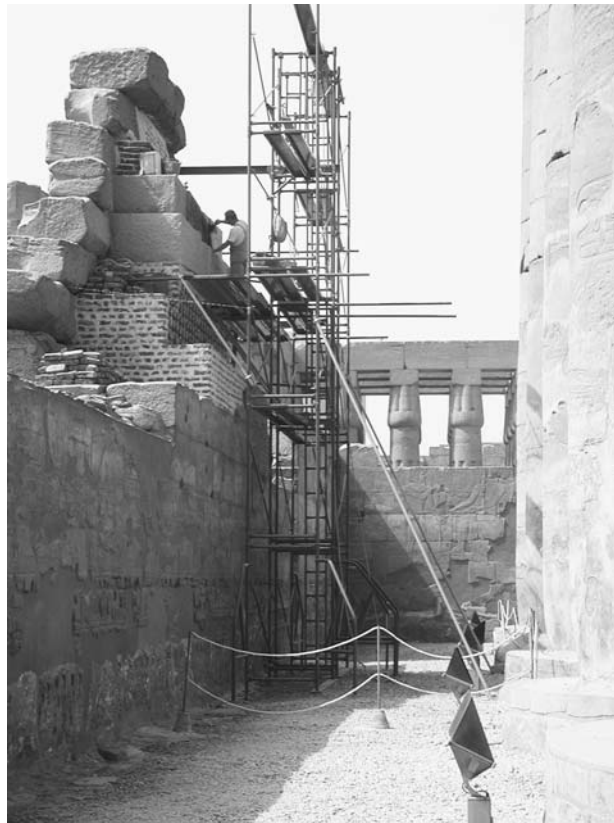
Figure 9. Brick buttress built against projecting eastern wall section of the Colonnade Hall, Luxor Temple, view from the north; Dany Roy. Photo by Ray Johnson

Because of the serious weakening of the stone walls of the Luxor Temple complex due to high groundwater, the Epigraphic Survey, supported by the World Monuments Fund (a Robert Wilson Challenge for Conserving Our Heritage matching grant), proposed to stabilize this eastern wall spur by constructing a brick buttress against its inner face. Since a group of forty-eight decorated wall fragments join the wall at that spot, completing a scene featuring the divine barge of the god Khonsu in the Opet water procession, it was decided to integrate that group into the stabilization program and build it into the brick matrix at the base of the buttress. Thus the project accomplishes two major goals: the entire wall is stabilized, and the restored fragment group (which will assist in supporting the wall) will complete the first register of the Opet Register reliefs in that spot.

This project was inaugurated in January under the supervision of stone cutter Dany Roy. Construction of the brick buttress began in February and was completed during the second week of March, seven courses high, a little over 6 m in height. Total volume of brick buttress: 20 cubic m; Building material: 7,600 bricks (380 bricks/cubic m) and 5,000 kg of mortar (250 kg/cubic m). An aluminum framed sign with diagrams of the stabilization work, drawings of the fragments to be restored, and text description was set up in front of the scaffolding to explain the project to the public.

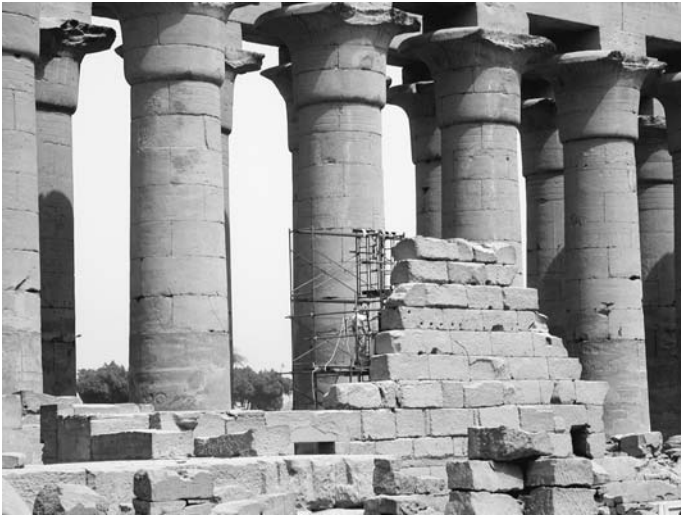
Figure 10. Projecting eastern wall section of the Colonnade Hall, Luxor Temple, view from the east. Photo by Ray Johnson

When the Colonnade Hall was excavated in the late nineteenth century by Georges Daressy, he found that most of the original side walls of the hall were missing, quarried away in the Middle Ages for building material, down to the lowest wall courses which preserve the famous Opet procession reliefs. One exception is a small section of the southern end of the eastern wall, which sticks up about 7 m above the preserved wall area. This projection consists of the exterior courses of the eastern wall, while the inner block fill and inner wall courses are missing. While the interior walls of the hall are vertical, the exterior wall of the Colonnade Hall is battered, and while perfectly balanced, this exterior section appears to lean in at a precarious angle.

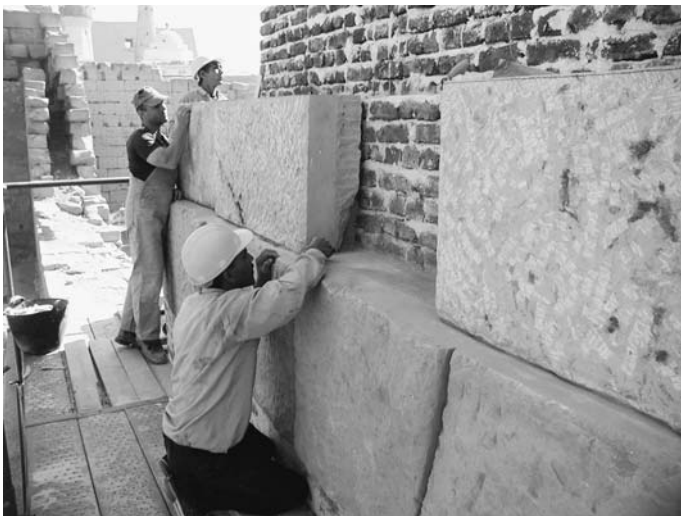
Figure 11. Laying sandstone veneer over brick buttress, Colonnade Hall, Luxor Temple, looking toward the north; Dany Roy, Ali Mahmoud, and Saber Ahmed Taya. Photo by Ray Johnson

The veneer row on course level 4 was finished (six slabs, 4.5 m long total; 1.25 cubic m of sandstone, weight of 2,500 kg) as well as the veneer row on course level 5 (above 4) was finished (six slabs, 4.23 m long total; 0.95 cubic m of sandstone, weight of 1,900 kg). The upper two veneer rows six and seven will be put into place and finished next season 2005/2006, and the forty-eight fragments of the Khonsu Barge group will be restored and infilled below (courses 1, 2, and 3) with a hydraulic lime and sandstone powder mortar. Before we left Luxor this season, on April 10 and 11, Hiroko and I placed ten dry sandstone fragments from the Khonsu Barge group on the wall, which will give the public a preview of what is to come in the fall. Permission was received by the SCA to leave our scaffolding in place against the wall, which

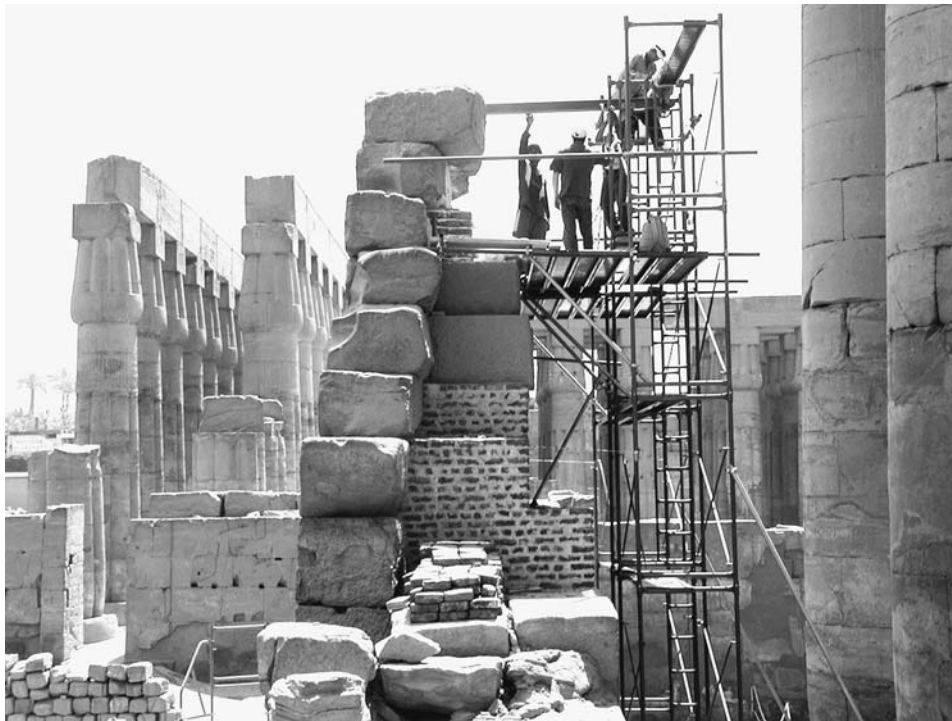
Figure 12. Brick buttress with sandstone veneer built against projecting eastern wall section of the Colonnade Hall, Luxor Temple, view from the north. Hassan Yousef Aly, Dany Roy, Saber Ahmed Taya, and Ali Mahmoud. Photo by Ray Johnson

In discussions with the SCA, and to make the buttress/wall support less intrusive, it was decided to cover the brick buttress with fresh-quarried sandstone veneer slabs cut to resemble the ancient blocks of the original wall. A covered stone cutting station was set up outside the enclosure wall east of the Colonnade Hall for cutting down the stone slabs before transferring them
