## GIZA PLATEAU MAPPING PROJECT

## Mark Lehner

## Introduction to Season 2016

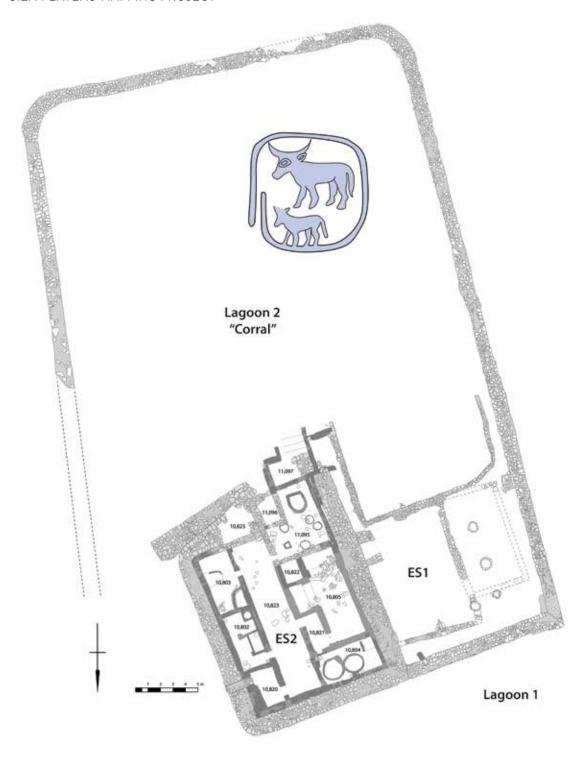
Figure 2. The compound in Area SWI, with south to the top — the orientation privileged by the ancient Egyptians, in contrast to north at the top. Insert: One of two corrals depicted on the upper (right) shoulder of the Early Dynastic ceremonial mace-head of King Narmer. Note the similarity of the SWI corral to the image on the mace-head (map: Rebekah Miracle from AERA GI)

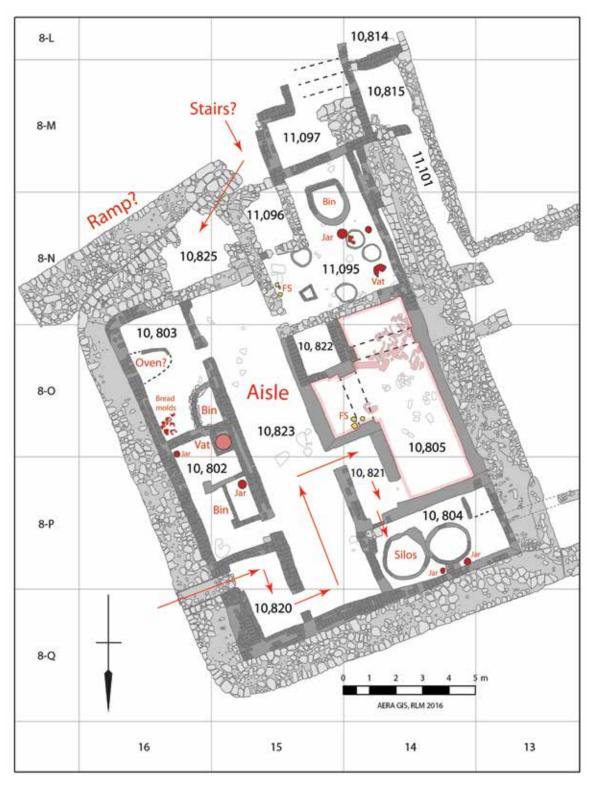
Figure 3. Internal structure of ES2 after Season 2016. FS = furniture supports. Red = ceramic vessels. Yellow objects are furniture supports. Generated from post excavation plans and from AERA GIS by Rebekah Miracle

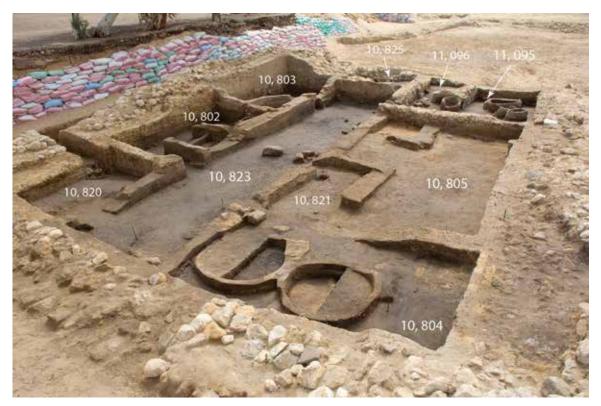
Figure 4. Room structure of House ES2 in the northeast corner of Standing Wall Island, with assigned space numbers. View to the southeast (photo: Dan Jones)

The layout of ES2 is unlike any other house we have uncovered at HeG or in the Khentkawes Town. A wide central aisle or hallway runs north to south down the middle. All the other chambers open directly or indirectly off this aisle (figs. 3–4). The aisle (10,823), 12.85 meters long, traverses most of the interior length of ES2. While the width ranges from 2.64 to 2.83 meters, the builders doubtless intended five royal cubits (2.62 meters), a dimension we find again and again across the HeG site.

A thick fieldstone girdle wall reinforces a much thinner outer wall of mudbrick on the east, west, and north sides of ES2, creating the appearance of a fortress. One entered at the northern end of the eastern wall through a corridor, 2.27 m thick. It gave access to the interior via a small vestibule (10,820), where a guard may have kept watch.

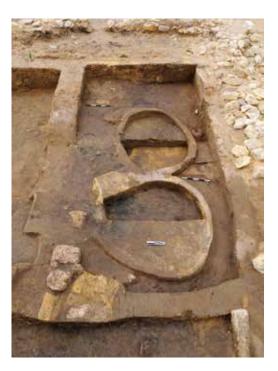
Figure 5. The Silo Room (10, 804) in House ES2; view to the west

Directly across the central aisle from the entrance vestibule stands a room (10,804) containing two silos (fig. 5). In 2015 we uncovered the base of one round silo here, and this season, excavating down to floor level, we found the base of a second silo. In modern times, someone

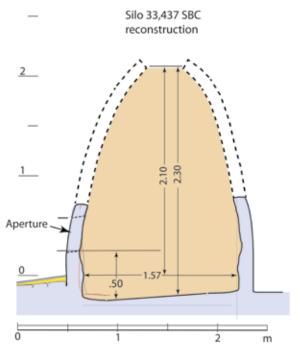
Figure 6. Schematic profile of an SBC silo on the basis of the measured profile at the eastern side of Silo 3.437 in 2014

cut down the ruins in this part of ES2, leaving the silos nearly flush with the floor. But the interior floors of these silos lie 16 to 30 centimeters below the truncated tops. The builders set the bottoms of the silos below floor level, as they did in the two silos we excavated in the Silo Building Complex (SBC) in 2014. The ES2 silos measure about 1.50 meters in diameter, a little less than 3 cubits (1.575 meters), with single-brick walls, 10 to 14 centimeters thick. With so little of the walls remaining, we cannot reconstruct the shape or height of the silos. However, since the ES2 silos are the same diameter as the SBC silos, they may have been the same shape and height as well. In 2014 I extrapolated the shape and height of the SBC silo walls, which were preserved to 0.9 meters high, and came up with an elliptical cone standing 2.1 meters above the floor level (fig. 6).

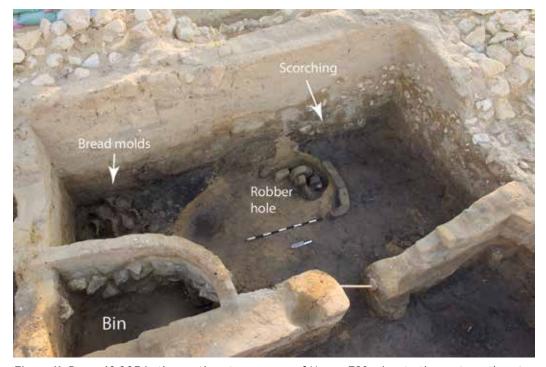
Figure 11. Room 10,803 in the southeastern corner of House ES2; view to the east-southeast (photo: Dan Jones)

Unlike most HeG walls, which are ankle- to waist-high at best, the eastern and southern walls of east room 10,803, adjacent to the Bin Room on the north, stand 1.85 meters high (fig. 11). The wall is heavily scorched for a length of about two meters, suggesting an oven may have once stood against it. Only a curving line of bricks remained because, prior to our work, someone had dug a pit down through the ruins and took out most of this hypothetical oven.

The bricks suggested the oven extended about 1.4 meters from the east wall, probably as a domed superstructure rising from a half-oval projecting base.

The Oven Room (10,803) also featured a bin,  $0.91 \times 1.43$  meters, formed by a wall curving across the northwest corner. Preserved to a height of 0.98 meters, the wall was built of mudbricks on a foundation of rough limestone pieces that protrude from the lower interior and exterior sides. The interior floor lies 0.20 meters above the chamber floor. While people probably filled the bin from above, they may have removed the contents from an aperture, 0.42 meters wide, near the bottom next to the west wall of the chamber. On the other hand, if they used the bin to store fuel for the oven, such as charcoal, straw, and chaff, they would not have taken these materials out of the small opening, which, in any case, they blocked at some point.

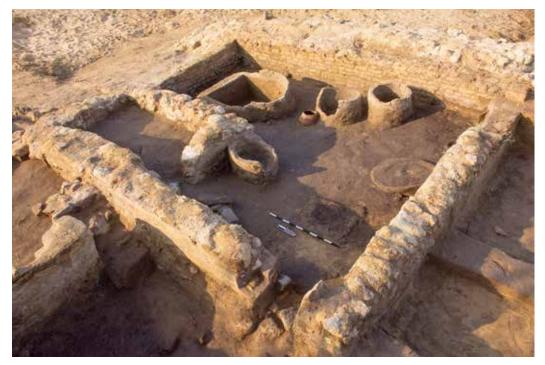
Figure 12. View of Courtyard Pantry (11095) and its annex (11096) showing the features within the space 11095; view to the southwest (photo: Dan Jones)

Across the aisle from the Oven Room, four steps led up through a narrow doorway into a large, L-shaped chamber (11,095) that appears to have been a storage and food processing area. In this space our team uncovered four silos, smaller than the two in the Silo Room, with outer

diameters ranging from 0.62 to 0.80 meters (fig. 12). These silos appear to have been placed more ad hoc—created for a particular purpose as necessary. They were less designed into the room space than the two big silos or subsidiary structures in the other chambers. Moreover, they were formed of clay more than mudbrick and set directly on the floor. Two on the east side of the chamber sit against the walls. One of these is preserved only slightly above floor level. The other three silos range in height from about 0.30 meters to more than 0.50 meters. None showed any signs of an opening at the bottom. People must have removed the contents from the top. They may have kept pulses, dried fruits, malted grain, and other foodstuffs in these small containers. In the bottom of one of the silos, we found two ceramic vessels that would have been used to measure out commodities (fig. 13): a cylindrical pot, known from tomb scenes to have been used to measure oil, and a pear-shaped vessel, with a capacity twice that of the cylinder. A shallow ceramic bowl lying next to the pots had served as a lamp, as indicated by the soot coating on the inside and outside of the rim.

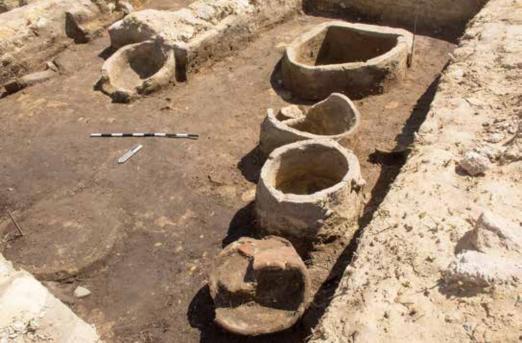
Figures 13–15. Clockwise from top left: (13)The two jars and a dish as found together in the silo on the left in figure 14; (14) Silos and a jar set upside down as a mini-silo in the western side of Room 11,095; (15) The large bin (background) and silos in Room 11,095. The bin, a jar set upside down as a container, two mudbrick silos, and the ceramic vat comprised a production line; view to the south-southeast (photos: Dan Jones)

Next to one of the silos, the inhabitants partially buried, upside down, a ceramic pot with its rim embedded deep in the floor. They cut its bottom cut off to create an opening, apparently so they could use it as another ad hoc storage vessel (fig. 14). Adjacent to the northernmost western silo, we found sitting upon the floor a large, deep ceramic vat (our type CD 25), such as we have found in several of the bakeries at the HeG settlement. This one appears to have crumbled in place.

A large horseshoe-shaped bin stands in the center of the southern leg of the room (fig. 15). It measures 1.64 meters north—south and 1.30 meters east—west across the widest point. The thin walls, the width of a single brick, were preserved to around 0.30 meters above the floor. The bottom of the bin lay more than 0.27 meters below floor level. The walls showed no sign of an aperture, so people must have added and removed contents from above. The team found a complete bread mold and a part of a bread mold on the floor at the southwest corner of this bin. Perhaps it served as a pottery stash. Elsewhere at HeG, we have found bins and boxes built into mudbrick walls stuffed with pottery. In two such compartments, we found, bread molds stacked upside down, one over another.

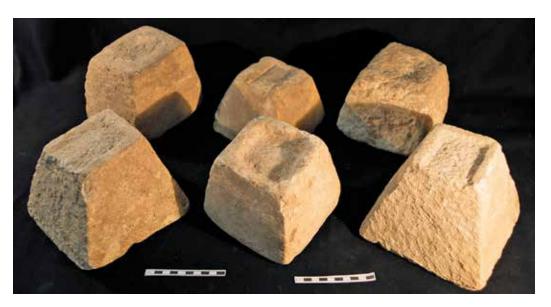
Figure 16. The six furniture supports from House ES2

Among the hodgepodge of common objects in space 11,095, the most remarkable, and perhaps most out of place, were three truncated limestone pyramidal furniture supports, similar to the three we found last year in Room 10,805, mentioned above (fig. 16). In our 2016 season, when we uncovered the first such object we thought it must be the fourth support that completed the set we found in 2015. But then we discovered two more in the same collapse deposit. So now we have a total of six from two different chambers, perhaps members of two incomplete sets. If they had all been used in the pilaster and niche room (10, 805) as supports for a bed and a chair, then the objects clearly moved about after abandonment.

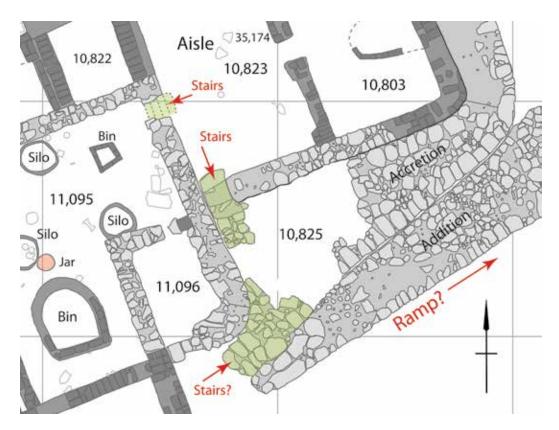
Figure 17. The southeastern corner of House ES2, showing stairs (green) from the lower floor level of the aisle up into rooms 11,095 and 10,825, and possible stairs (or stone blocking?) from the southern edge of the larger enclosure — the hypothetical corral — up to floor level on room 10,825. Note that north is up, unlike figures 2 and 3, where north is down. We found the stairs from the central Aisle (10,823) into room 11,095, collapsed, with stone pieces from the steps scattered in the aisle (map: Rebekah Miracle from AERA GIS)

The small space at the south end of the house (10,825) offered a back entrance off the "corral." From the central aisle in the house, people accessed this small rear chamber via four steps leading up to the floor, which lies 0.47 meters above the general floor level of the house (fig. 17). Anyone who continued south into the corral had to descend 0.75 meters down what appears to be a short stairway, formed as a series of stones set in pairs, at the southwest end of room 10, 825.

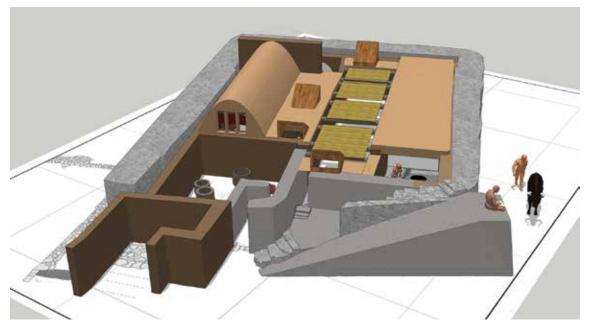
Figure 18. A 3D model showing possible roofing over ES2, including a leaning vault over the "reception hall"

able, light cover of reed mats on wooden spanners — palm logs could span this 5 cubit (2.62 m) width — would offer shade and admit the breezes (fig. 18).

The reception hall (10,805) in the core house was most likely roofed with a vault, following Arnold's reconstruction of the priest's houses in the Khentkawas Town: a parabolic leaning vault extending over the hall (fig. 18). Windows in the end walls would allow pleasant crossventilation with the northwesterly prevailing winds.
