TELL ASMAR, KHAFAJE
AND KHORSABAD

SECOND PRELIMINARY REPORT
OF THE
IRAQ EXPEDITION

By
HENRI FRANKFORT

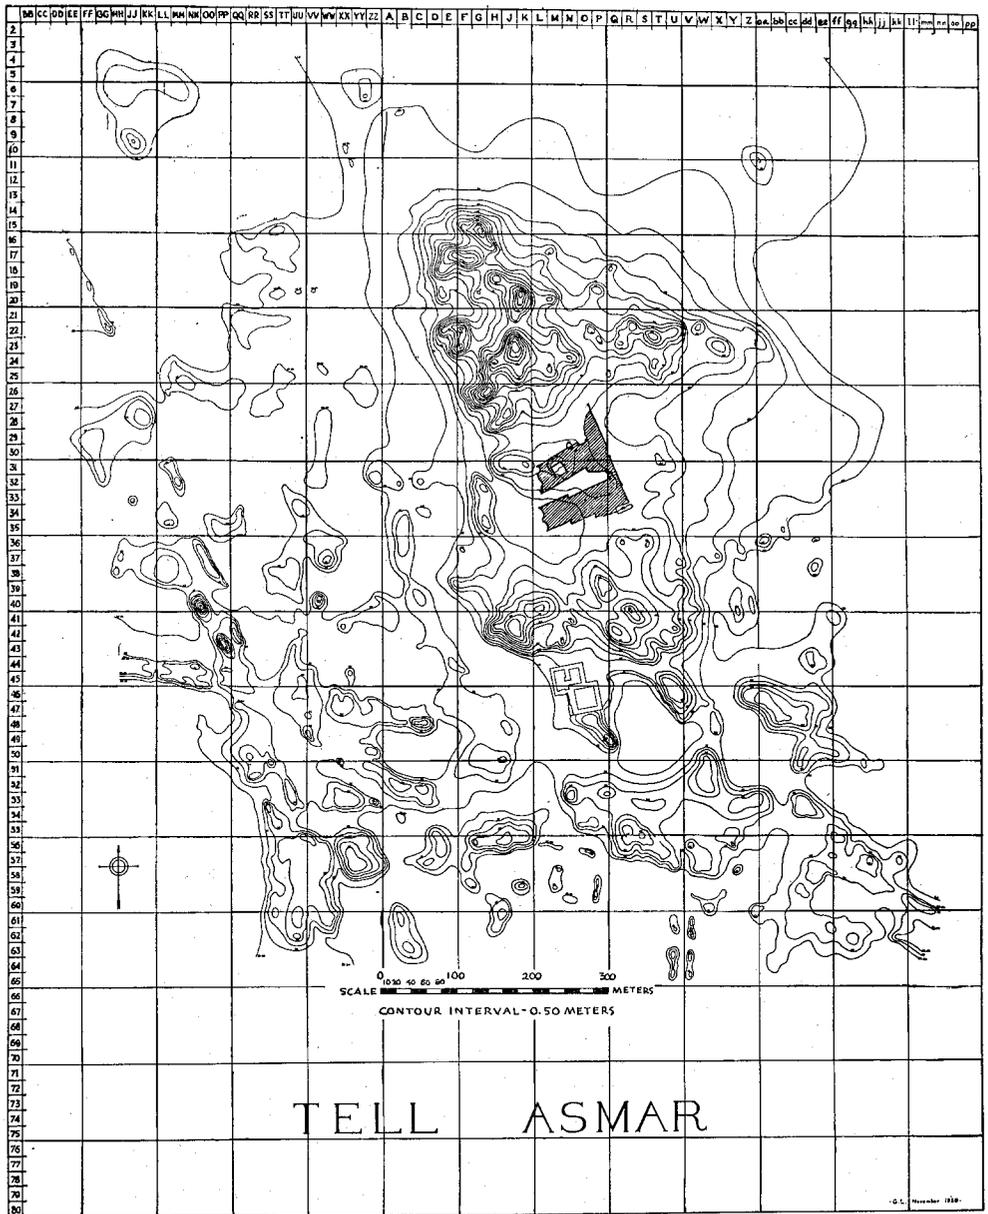
FIG. 1.—Contour map of Tell Asmar. The headquarters building of the expedition is outlined in M-P 44-47. North of it are the palace excavated during the first season and the southern building, both shown by hatching. On the farthest hillocks, northwest of the palace, Akkadian buildings were uncovered during our second season.

Mr. Lloyd, who was in charge of the work in the palace complex, started investigations in a large court⁴ located in O 30-31 and P 30 (cf. Fig. 1). Last year's discoveries at this point had shown that walls of an early period rose without interruption to the surface of the tell. We had found rebated doorways also, a certain indication of important buildings. The only evidence here of any notable activity on the part of later builders was that of a drain constructed of baked bricks and rebuilt twice, each time, of course, at a higher level (in 1 P 31). Originally laid down by Urninmar, it had been reconstructed by Urningishzida (whom we suppose to have been his brother⁵), thus proving the precedence of the former. Urningishzida used Bilalama's temple bricks alongside those stamped with his own name. Ibiq-Adad I then rebuilt the drain, but the remodeling which this part of the palace underwent in the time of his grandson Ibalpel seems to have affected among other things the system of drainage, so that the old course was altered.

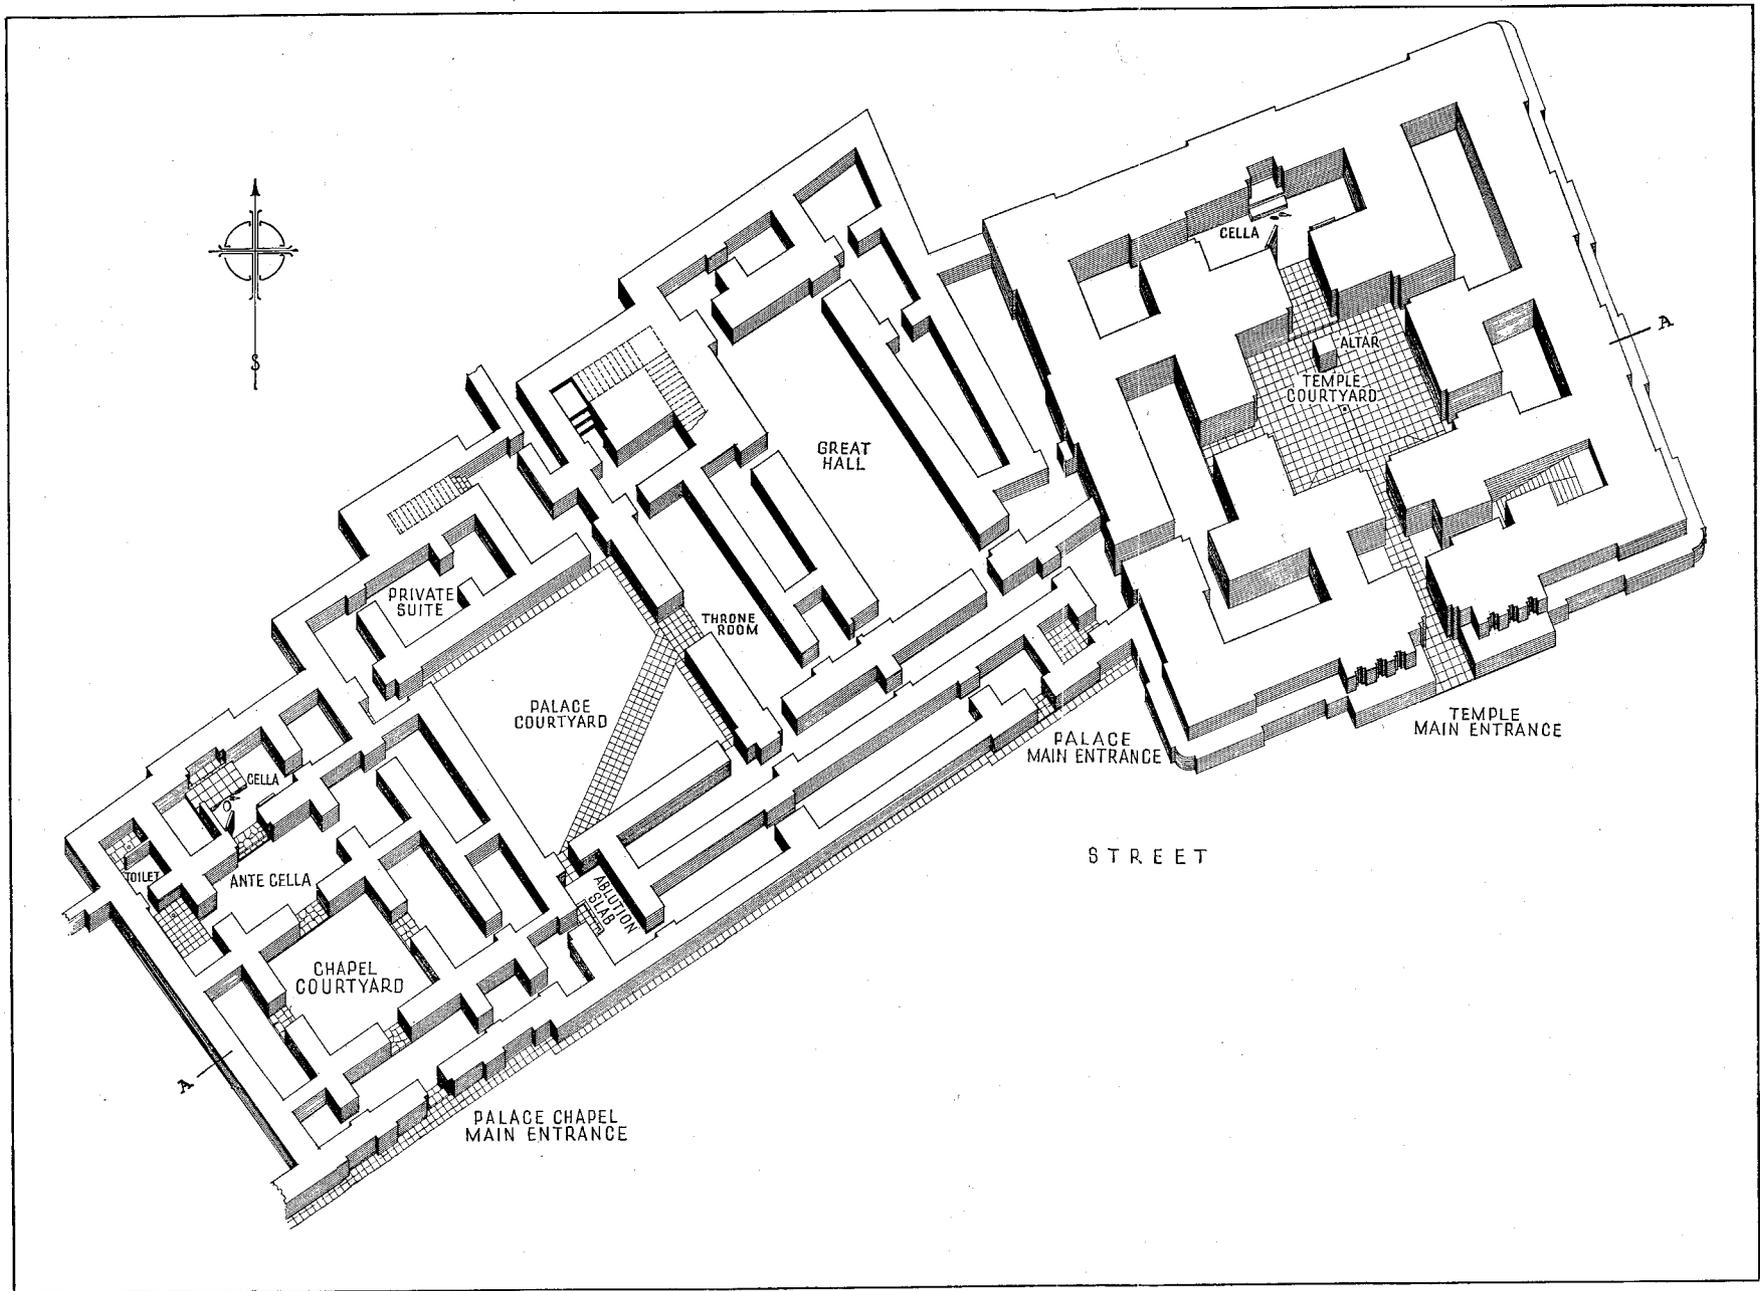
FIG. 3.—Plan of the palace and temple group in the time of Ilushulia, son of Ituria. Scale, 1:400

Before considering the palace and temples in detail, we must say a few words about what is hypothetical in the reconstruction. The plan in Figure 3 is based on ample evidence throughout; the record of objects found on the site will be published in a later report. In the elevation (frontispiece) the height of the roof above the floors is, of course, a matter of surmise; but we know that the doors of the Gimilsin temple must have been almost as high as they are shown in Mr. Lloyd's reconstruction because the walls are preserved to a height of over 5 meters. We have omitted the battlements usually shown in the drawings of Babylonian temples, as there is no good evidence for their existence before Assyrian times. The flat roof was probably covered with bitumen to make it rain-proof; perhaps this was covered with mats, as the roof would have been used for sleeping in the summer, and the heat of the day would have softened the bitumen if it had not been protected. The roof was probably surrounded by a simple parapet, and the water drained off by troughlike spouts of baked earthenware. We found such spouts in our excavations. Drip-pavements of baked bricks were found at all levels, and one such pavement contained three large jars, obviously placed so that they could receive jets of water. Mr. Lloyd has therefore restored two groups of three spouts each in the palace façade. The elevated roof of the great hall was almost cer-

room of a small ablution place. It is almost hidden in the restored plan (Fig. 3), because this was drawn in isometric perspective for the sake

pivot of the door passed to rest upon the stone below. Figure 13 shows one of these stones after the box had been removed. The doors of the cella could not be opened farther than is shown in Figure 3. Behind the left (western) door we found traces of a screen of reeds imbedded

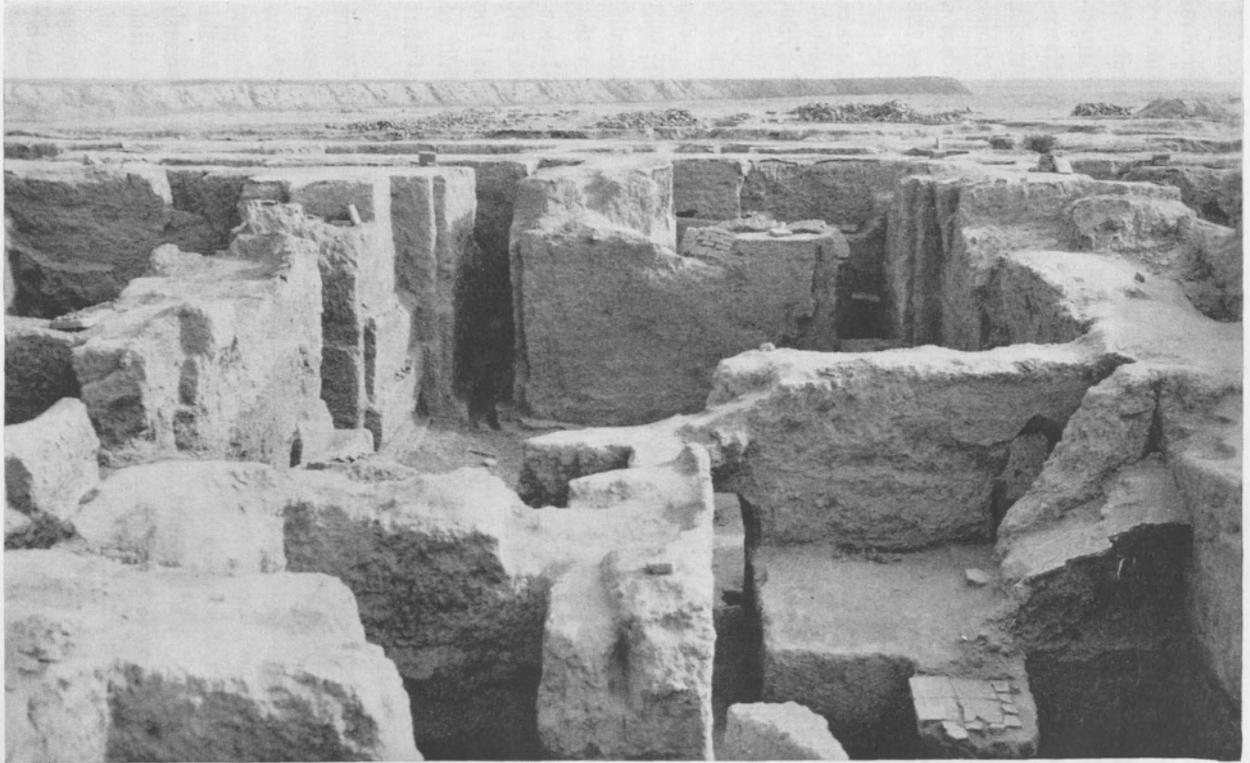
FIG. 4.—The courtyard of the Gimilsin temple, from southwest

rooms (cf. Figs. 3 and 16). On the extreme right edge of the picture is the entrance to the anteroom, 1 P 31, in which the drain was built later (cf. p. 4). In the background is the round well (1 P 30) built by Ibal-pel,⁸ which destroyed the earlier structures at that point.

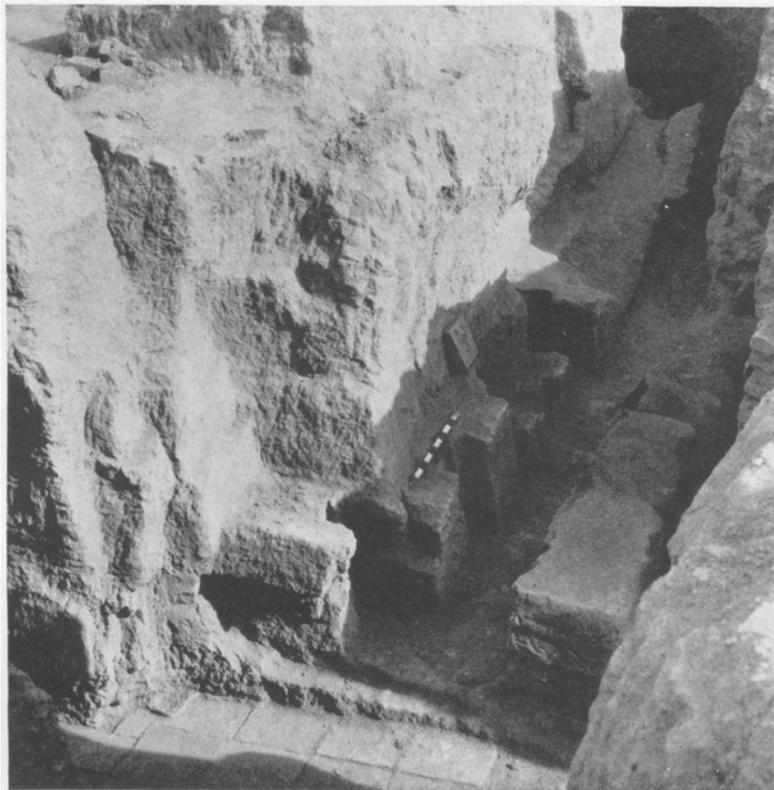
FIG. 5.—Ornamental recesses in the eastern tower of the Gimilsin temple disengaged from the retaining wall built in front of the towers and temple wall, from southwest.

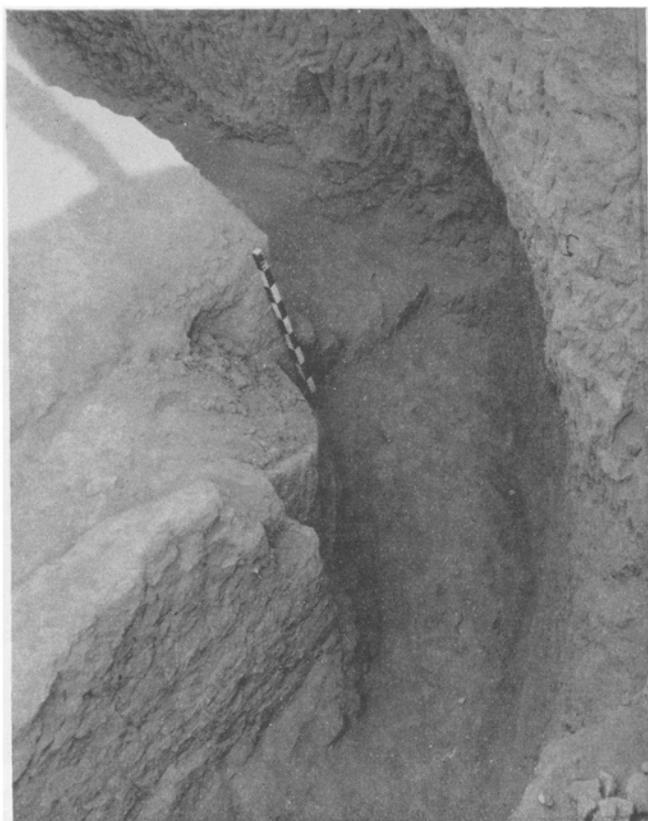
FIG. 6.—Corner of the retaining wall around the Gimilsin temple

the main temple wall was a low retaining wall with corners of an unusual shape (Fig. 6). This was evidently a later addition, and it helped to preserve the lower part of the ornamented panels on the towers. The retaining wall can be traced on the northern, eastern, and southern sides; but just after it turns at the southwest corner it is bonded

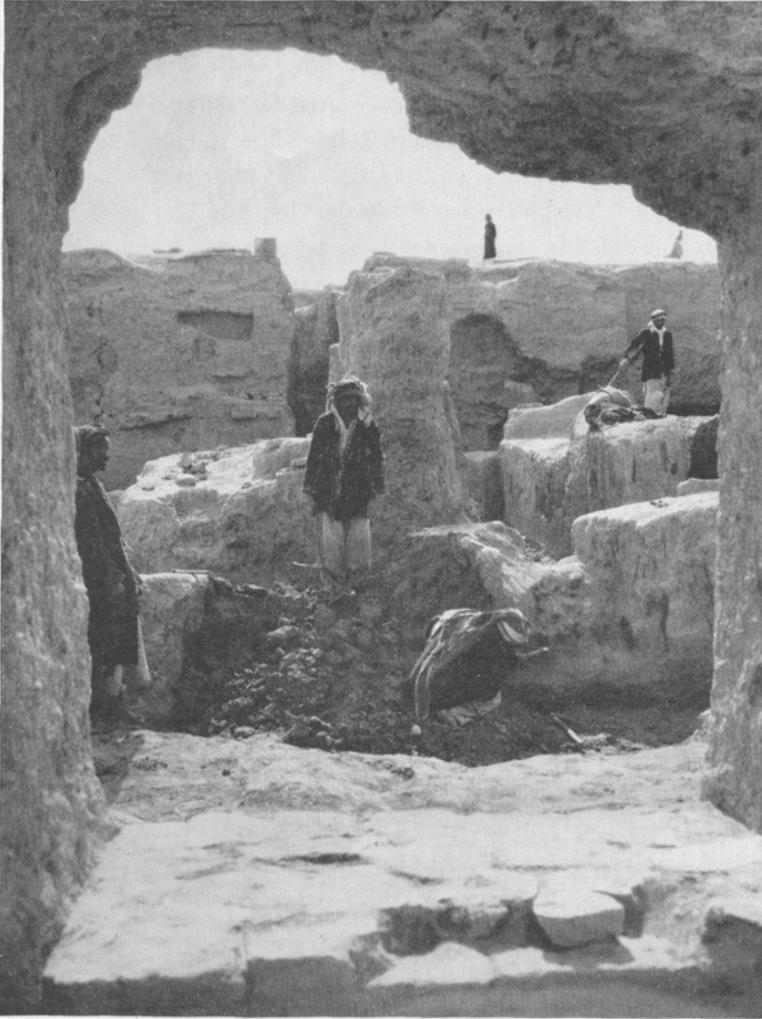
earliest building at this spot can be seen in Figure 8, where the kneeling workman is tracing the few courses of bricks which are left standing

FIG. 8.—Courtyard of the palace chapel as seen from the cella. This area later became the outer courtyard of Figure 16.

from the original foundation. The workman standing in the center has his shoulder at the level of the Urninmar building, and the man on the right is standing on its floor.

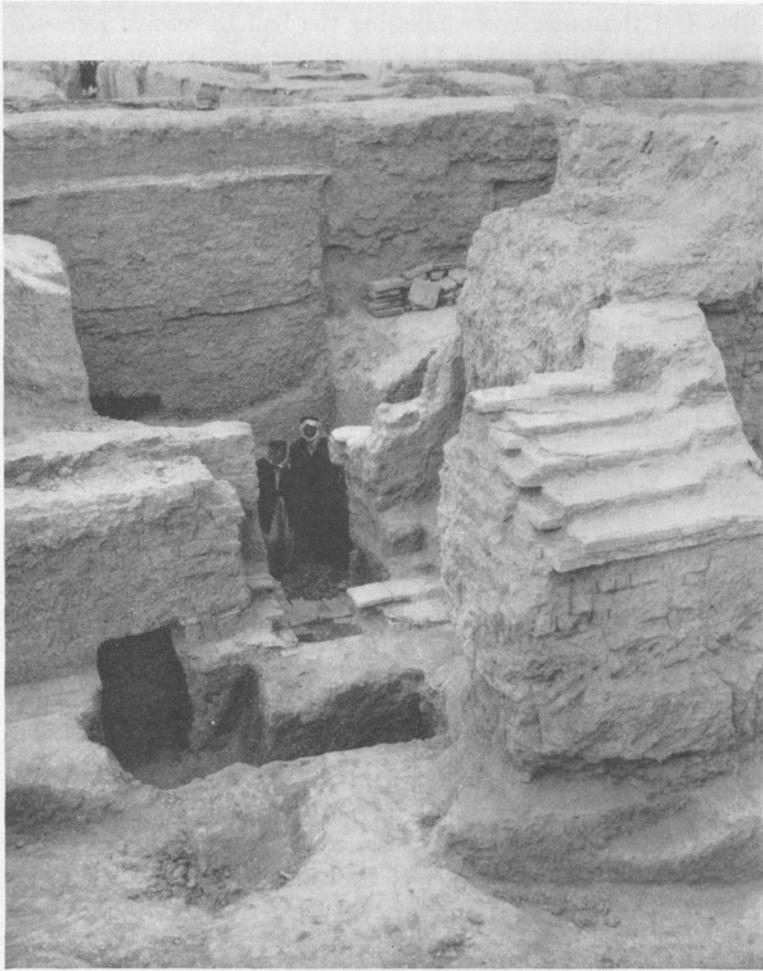
FIG. 10.—The main entrance to the palace, showing from top to bottom the two steps of Ibalpel (baked bricks removed); the five steps of Ibiq-Adad I (still in position); the white pivot stone of an intermediate layer (farther back); Bilalama's steps (partly removed); and, lower down, one step of the first palace.

lel case being provided by the palace entrance, which remained in the same spot for over three centuries (Fig. 10).

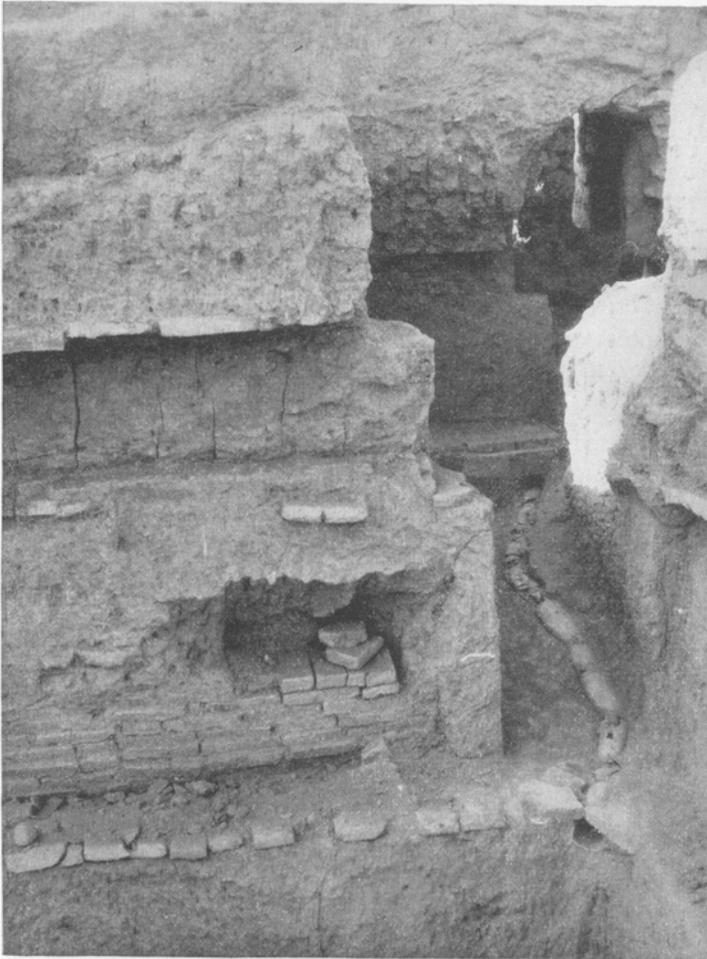
FIG. 11.—West corner of the palace courtyard, showing the levels of Ilushuilia, Bilalama, and Urninmar's first rebuilding. The drain in Ilushuilia's layer leads from the ablution slab in the anteroom of the private suite into the courtyard.

In the foreground of Figure 11 is the edge of a pavement of baked bricks, belonging to the first palace courtyard, and in the wall is a revetment of un-inscribed baked bricks. Next there is a portion of a wall of sun-dried bricks, belonging to the same period. Upon this Bilalama founded the walls of his palace, the floor of which is indicated by a few pavement bricks. A vertical line of light in the upper right-hand corner of the photograph shows the position of a door in the Bilalama structure (cf. Fig. 16), the palace that was burned in the great conflagration (probably in the reign of Isharramashu). The remains of these burned walls were used as foundations in the reconstruction carried out by several successive rulers, among whom was Urninmar, who later rebuilt the palace entirely. His floor level had been removed when this photograph was taken.¹² We also went down well below the pavement of the earliest palace in order to make sure that there was no earlier building.

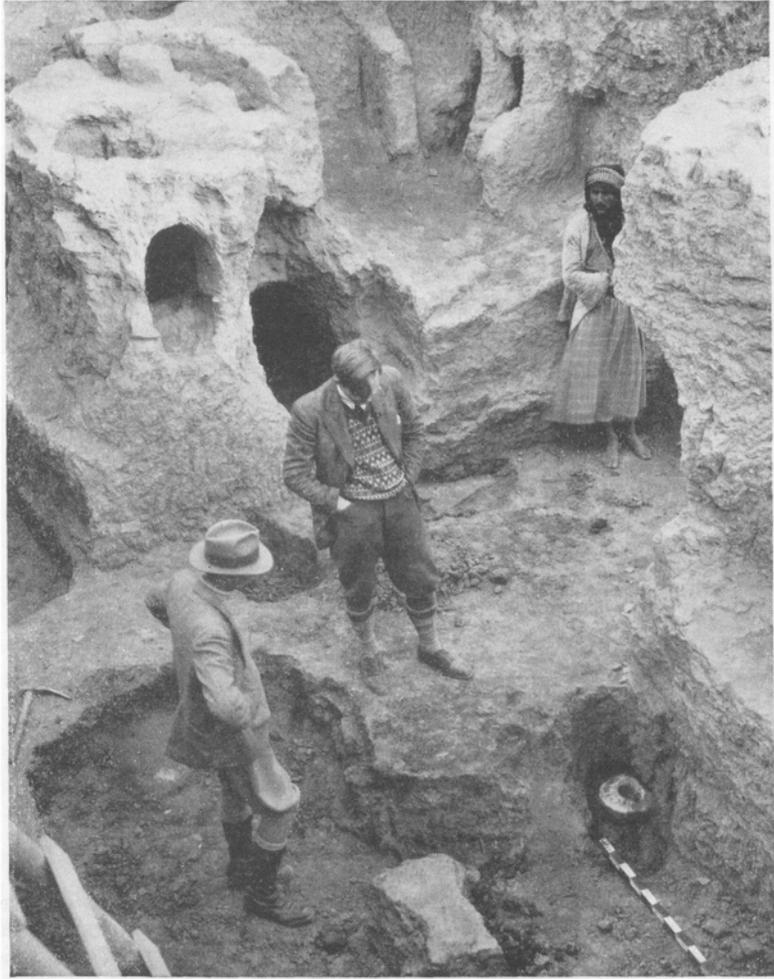
FIG. 13.—One of the pivot stones in the sanctuary of the Gimilsin temple after removal of the mud brick "box" which surrounded it. In the background is a smelting furnace erected after the conflagration.

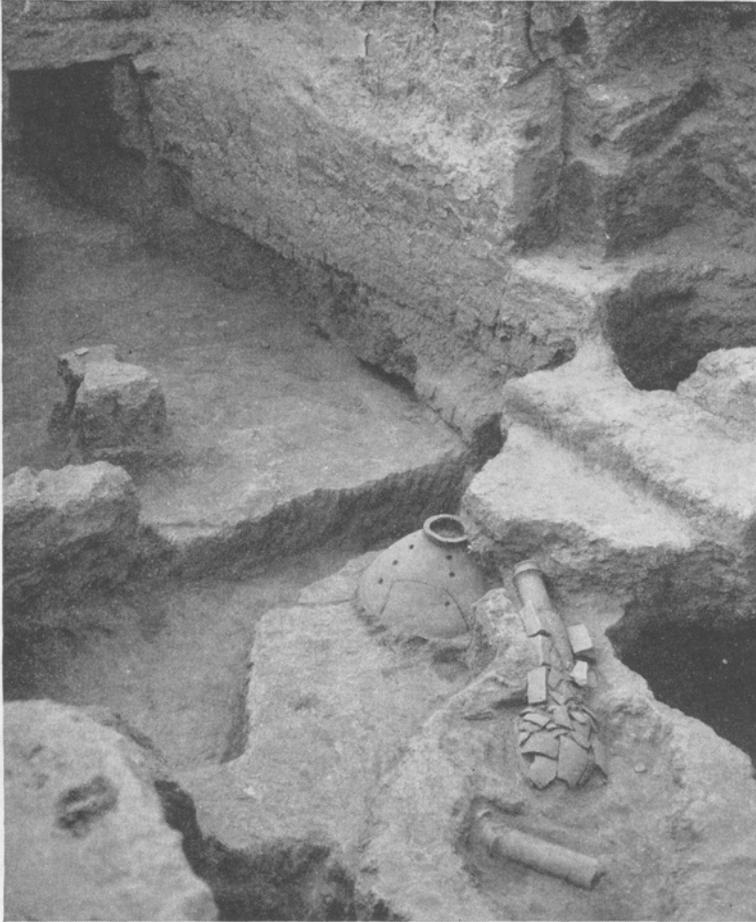
FIG. 14.—Pottery drains in the pavement in front of the niche in the cella of the Gimilsin temple. The hole dug in the platform was made by ancient robbers digging for the foundation deposit.

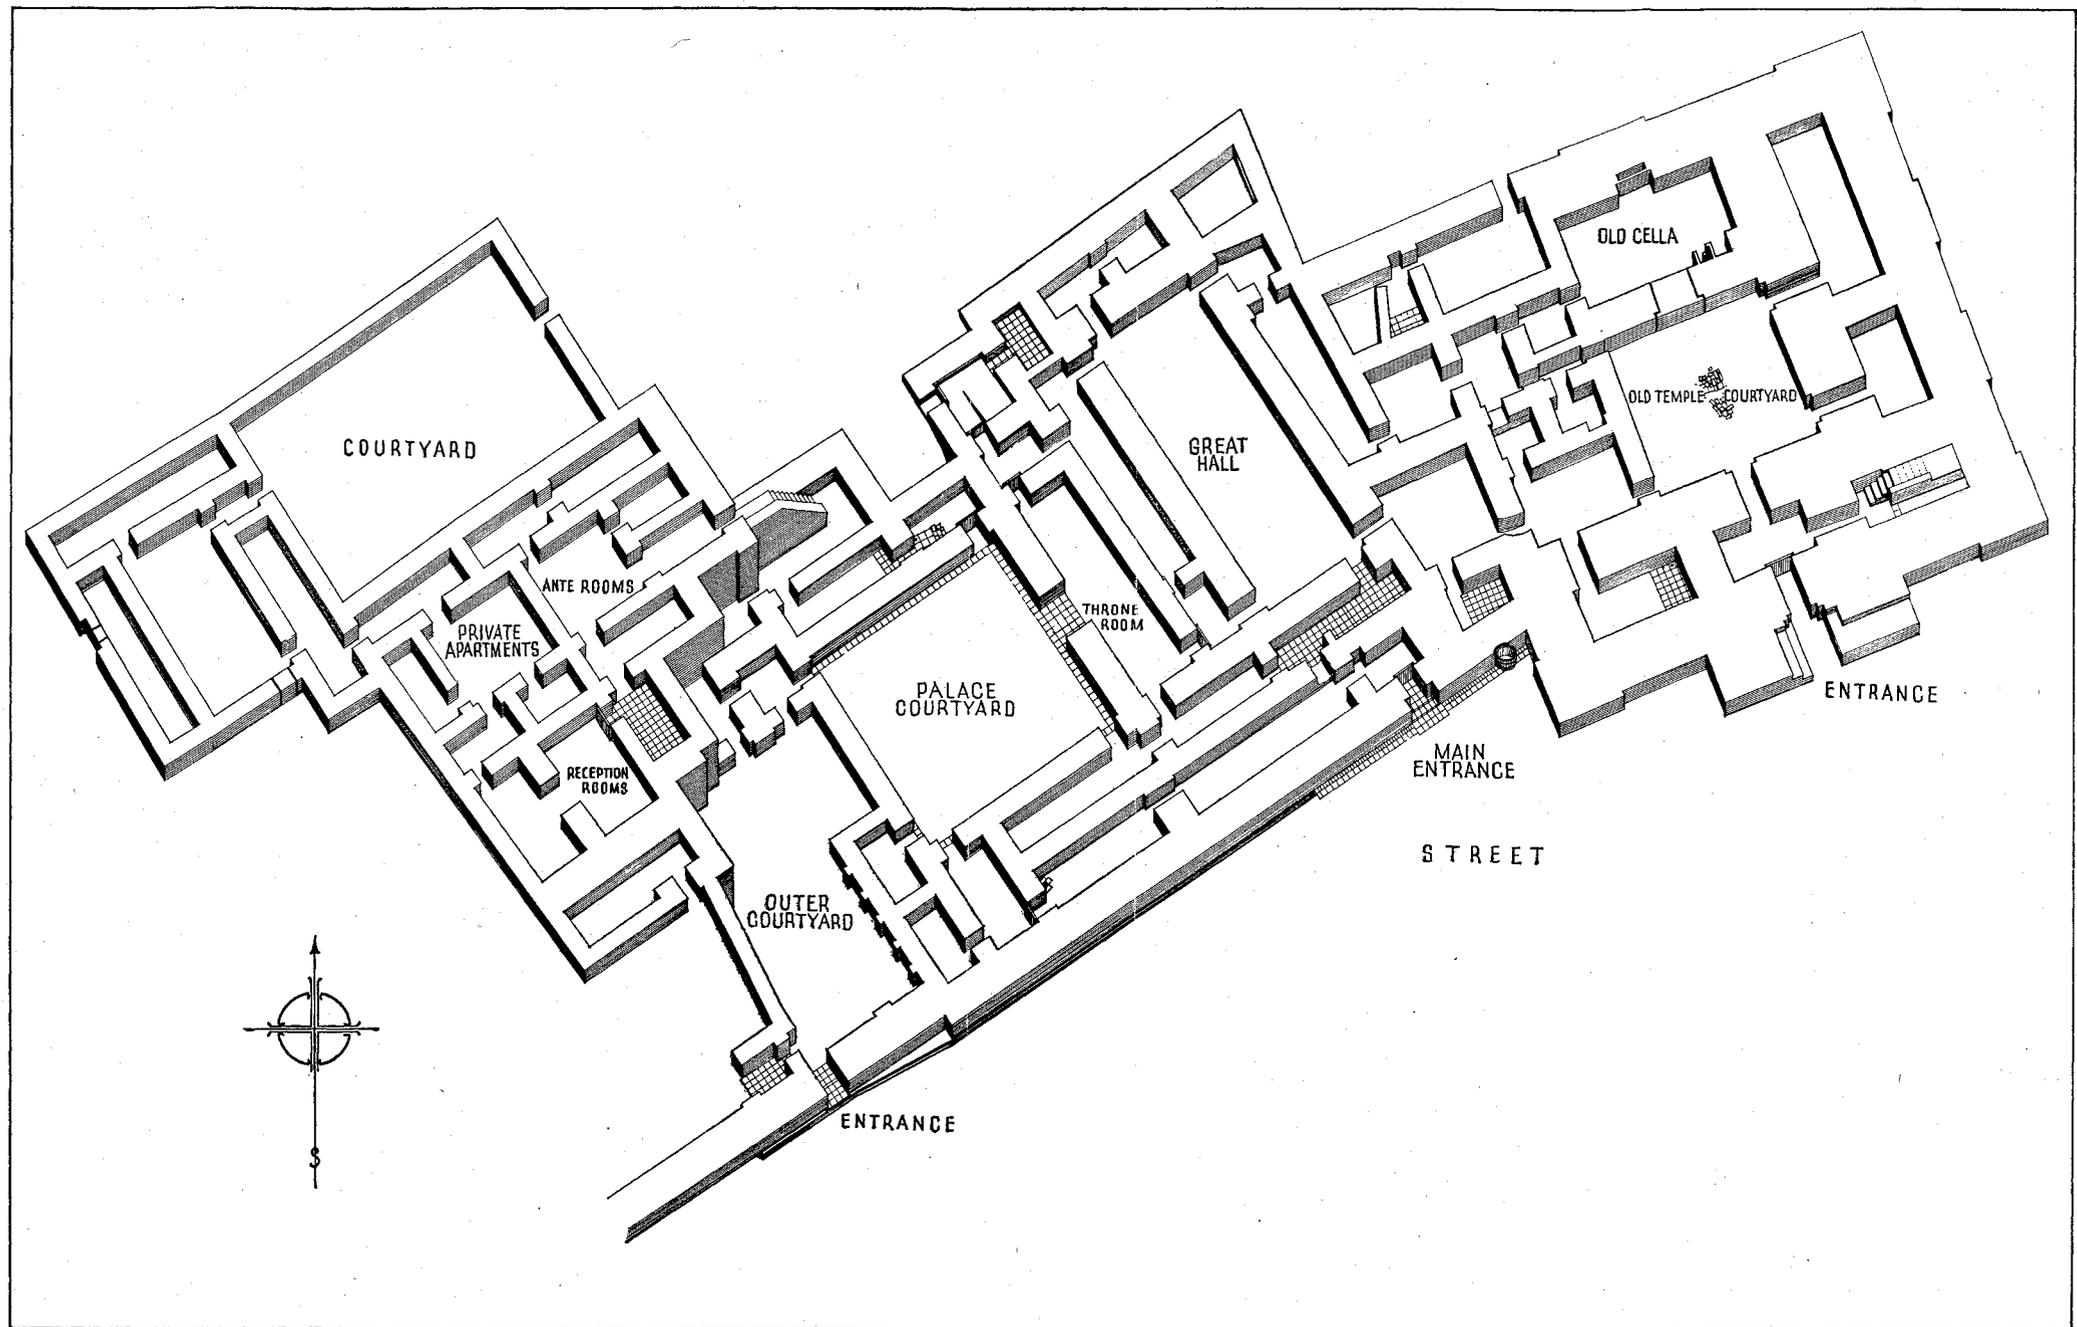
FIG. 16.—Plan of the palace in the reigns of Bilalama and Isharramashu. Scale, 1:400

The main difficulties encountered were due to an unusual phenomenon which occurred in the western part of our complex. There we found remains of the same period standing at two levels which differed by more than 2 meters (cf. Fig. 16). In our first season's work we had found baked bricks stamped with the name of Bilalama almost at the surface of the mound in L 32. The floors of the rooms in this area were strewn with a layer of ashes and rubbish. We thought at first that Bilalama's bricks had been re-used by some successor; but when we penetrated beneath Urninmar's level in the area just west of court 1 M 31 (Fig. 7), we found the correct explanation. There, some 2 meters below the surface, we found no walls, only a thick gray rubbish layer containing ashes from the great conflagration which had destroyed Bilalama's palace. This refuse layer stopped at a wall on the north, which seemed to be a retaining wall; beyond it were the rooms near the surface where we had found the pavements and revetments of Bilalama. Later we found north of the palace courtyard a long staircase which apparently was used to reach the higher rooms.

Kirikiri's son Bilalama entirely rebuilt the palace, the restored plan of which is shown in Figure 16. The first feature which strikes us is the encroachment of the palace on the old Gimilsin temple. The outside walls were still used, but the cella was cut off from the courtyard. It was now connected with a new set of rooms; these have thin walls and are partly accommodated within the thickness of the old temple walls, which are cut away where necessary (cf. Fig. 4). The western tower of the former temple entrance was strengthened and

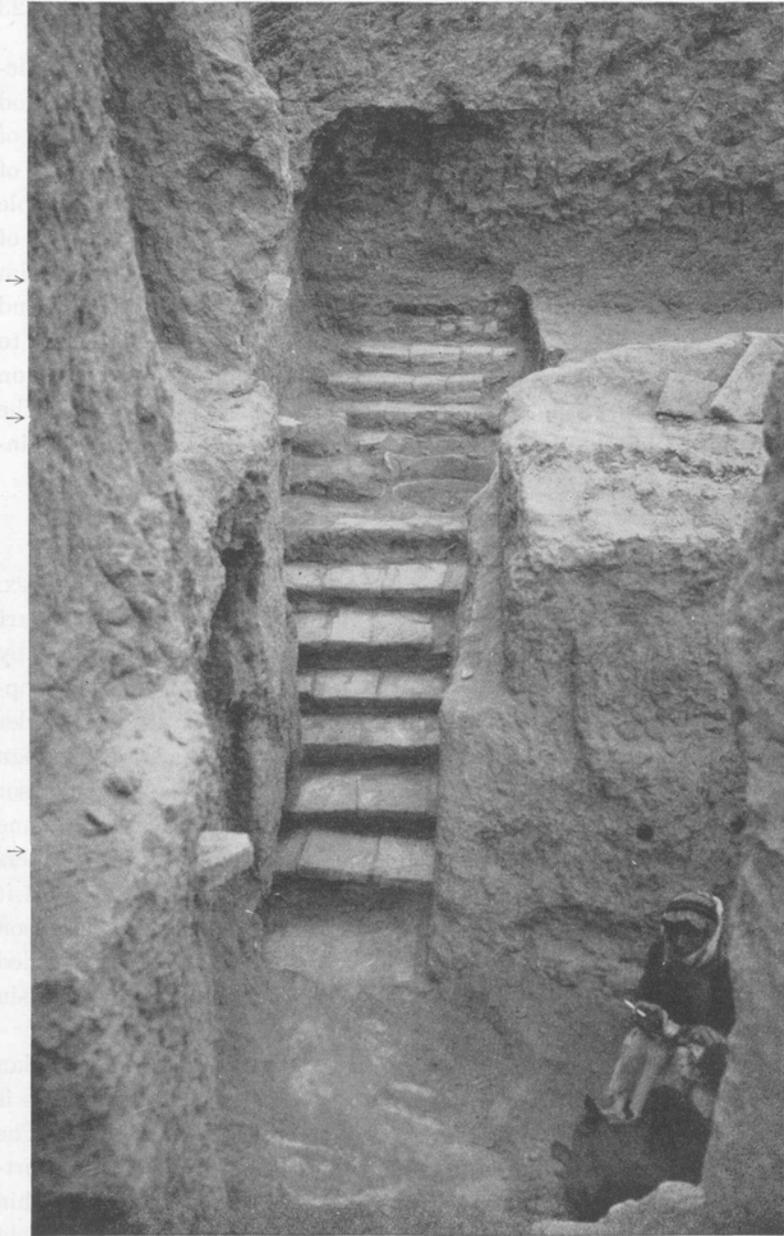
FIG. 17.—Staircase constructed by Nurakhum. Three pivot stones at the left (marked by arrows) show the slope of a ramp which took its place in the palace of Bilalama.

The central part of the palace was not greatly changed. The staircase north of the throne room was replaced by a ramp, the slope of which we can determine by means of pivot stones (Fig. 17). The ad-

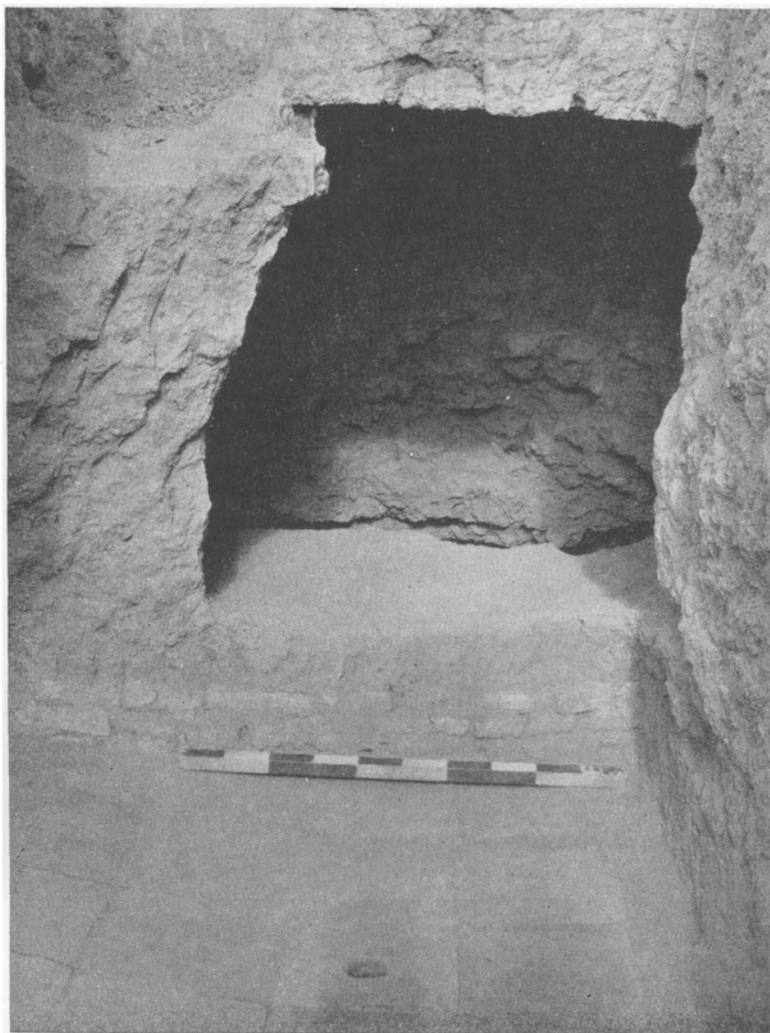
FIG. 18.—Paved room in Bilalama's palace

joining paved room may have been a bathroom or perhaps merely a light shaft for the surrounding rooms. The easterly corner of this room is shown in Figure 18. The Bilalama pavement shows clearly, with three or four courses of the wall which belonged to it. Above the wall there was a layer of rubbish; and above that, the foundation of

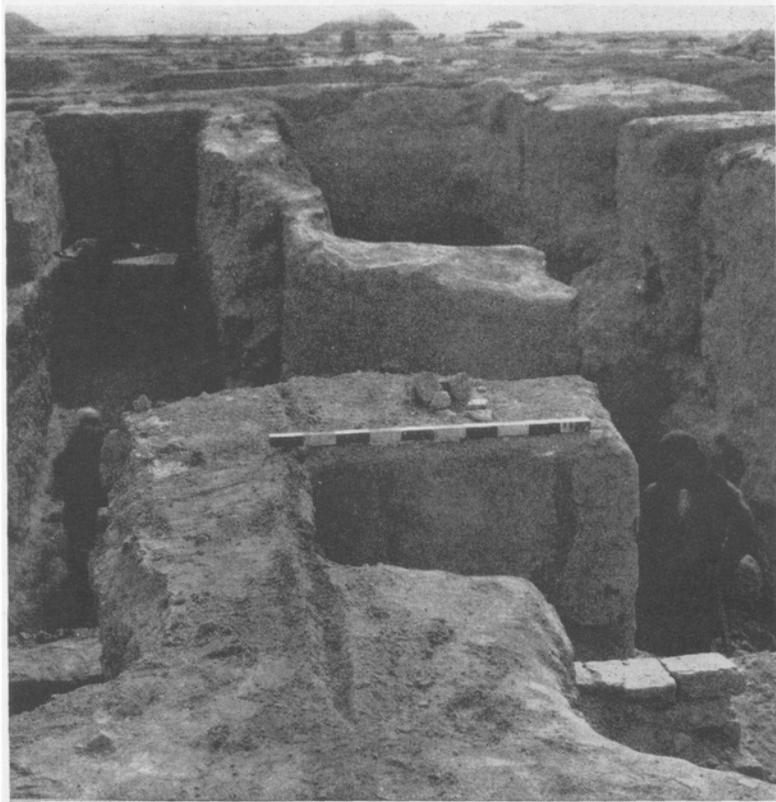
FIG. 19.—Foundations of Ibiq-Adad II cutting into walls of Urninmar

stick rests on one of Urninmar's walls. At right angles to this wall, beyond the doorway, we see a wall combining materials of the two periods. The Urninmar bricks are seen as a shell on the right face of the wall; the remaining brickwork is that of Ibiq-Adad II, most of which

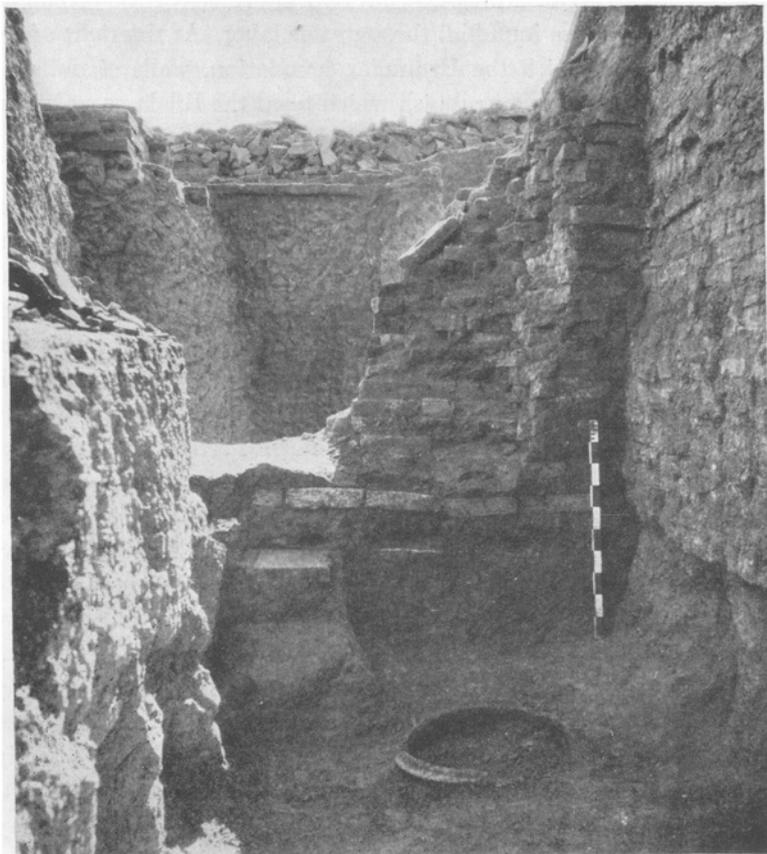
FIG. 20.—Walls of Bilalama and Urninmar

The room at the southwest corner of the palace courtyard is shown in Figure 20.¹⁶ The baked brick foundation at the back of the room

belongs to Urninmar's building. A white line 20 cm. below its base is formed by a decayed mat upon which a wall of Bilalama's palace had been built. To the left of this line a baked paving-brick shows the actual floor level in Bilalama's time. Here then the Bilalama wall was preserved to a height of only 20 cm. It bears traces of the conflagration, similar to those found all through this layer. At the right of the photograph, level with the Urninmar foundation, walls of unbaked bricks are seen resting on rubbish which filled the Bilalama palace at this spot. All this had to be removed before we could trace the earlier buildings.

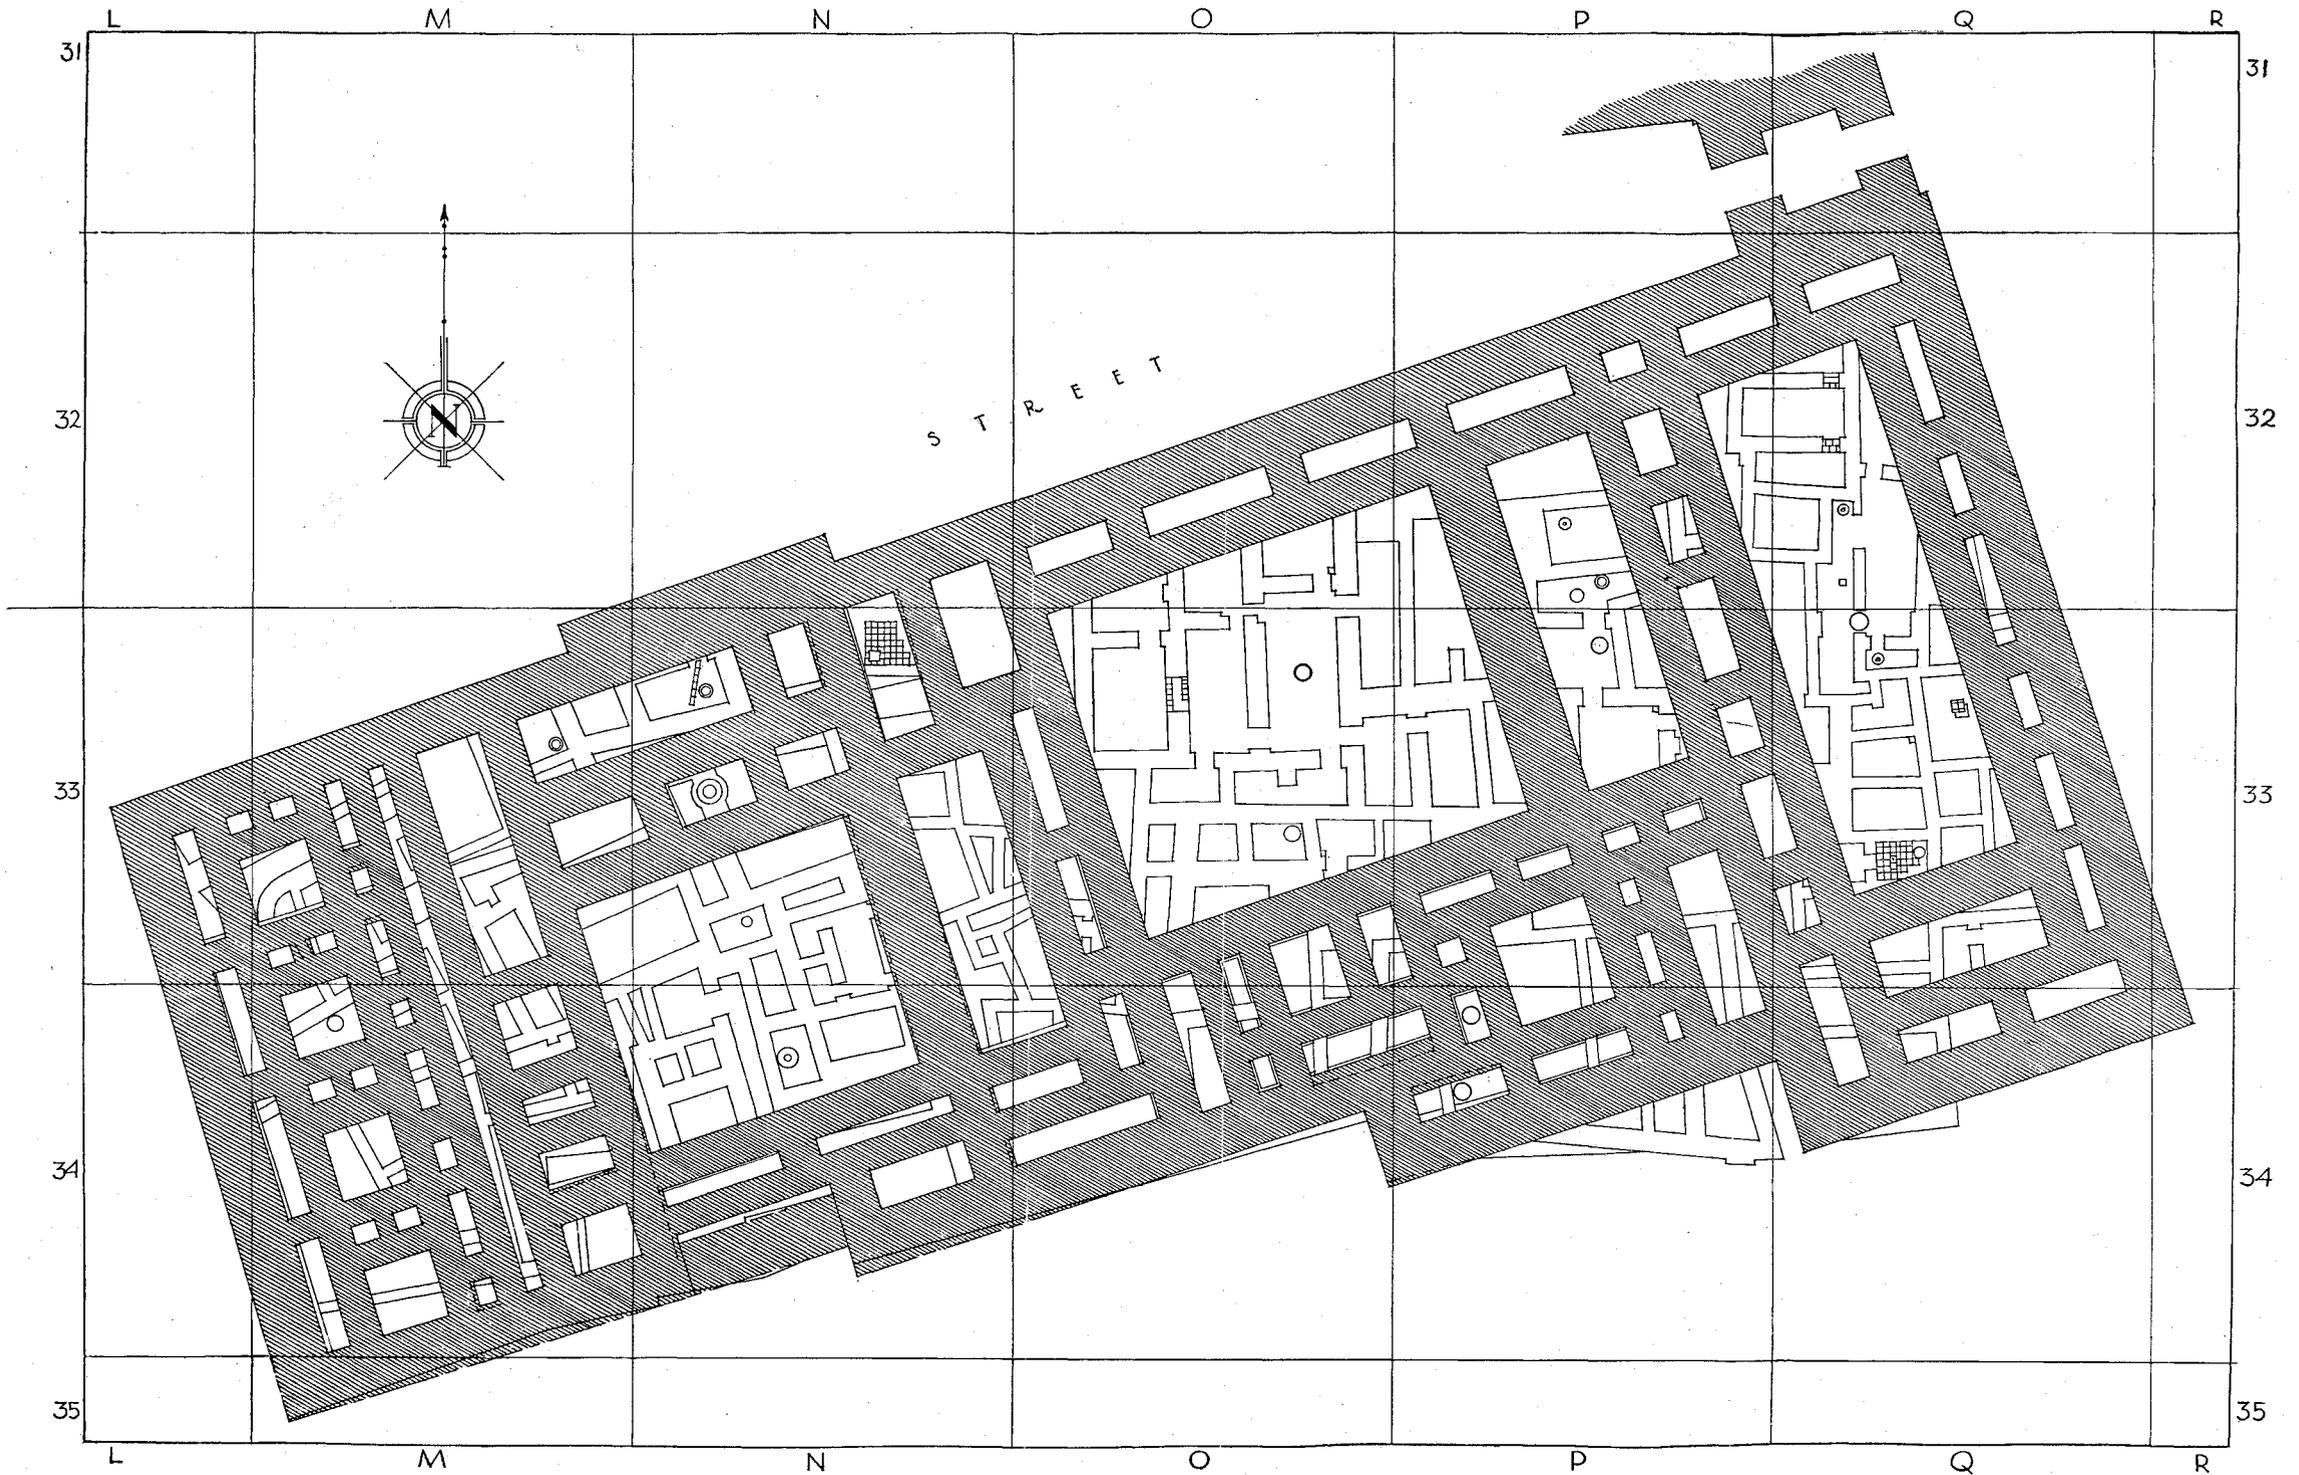
FIG. 21.—Plan of the southern building. Scale, 1:400

Mr. Loud's very precise observations make it certain that the foundations were laid by digging trenches with almost vertical sides, without regard to the ancient house ruins. The trenches were then filled with brickwork starting from one or both ends. The alignment of the walls was adjusted as the work went on; irregularities in deeper layers are shown by broken lines beneath the hatching in Figure 21. As soon as we attempt to reconstruct the doorways and rooms above the foundations we get into difficulties. For one thing, we do not know whether each cross-wall in the foundations corresponds with a wall in the actual building. In the palace we had no opportunity for making observations on this subject, because the later builders used the earlier walls, on the whole, as their foundations, and we did not descend into the foundations of the earliest palace. In the southern building we find a heavy monumental structure erected on a site occupied by small walls only, and it may be that the builders attempted to distribute weight evenly on their foundations and to prevent uneven settling by building a much more complicated net of foundation walls than they ever intended to raise above floor level. This is suggested especially by the western part of the building (Fig. 22). In any case the rooms were probably a little larger than the spaces between the foundations; for in the palace the actual walls were set back about 20 cm. on the foundations. There were neither door-sills nor pivot stones to show us the interrelationships of the rooms. It seems safe to assume, however, that an entrance flanked by two towers was based on the block projecting from the north wall in M 33-N 32.
