TELL ASMAR, KHAFAJE
AND KHORSABAD

SECOND PRELIMINARY REPORT
OF THE
IRAQ EXPEDITION

By
HENRI FRANKFORT

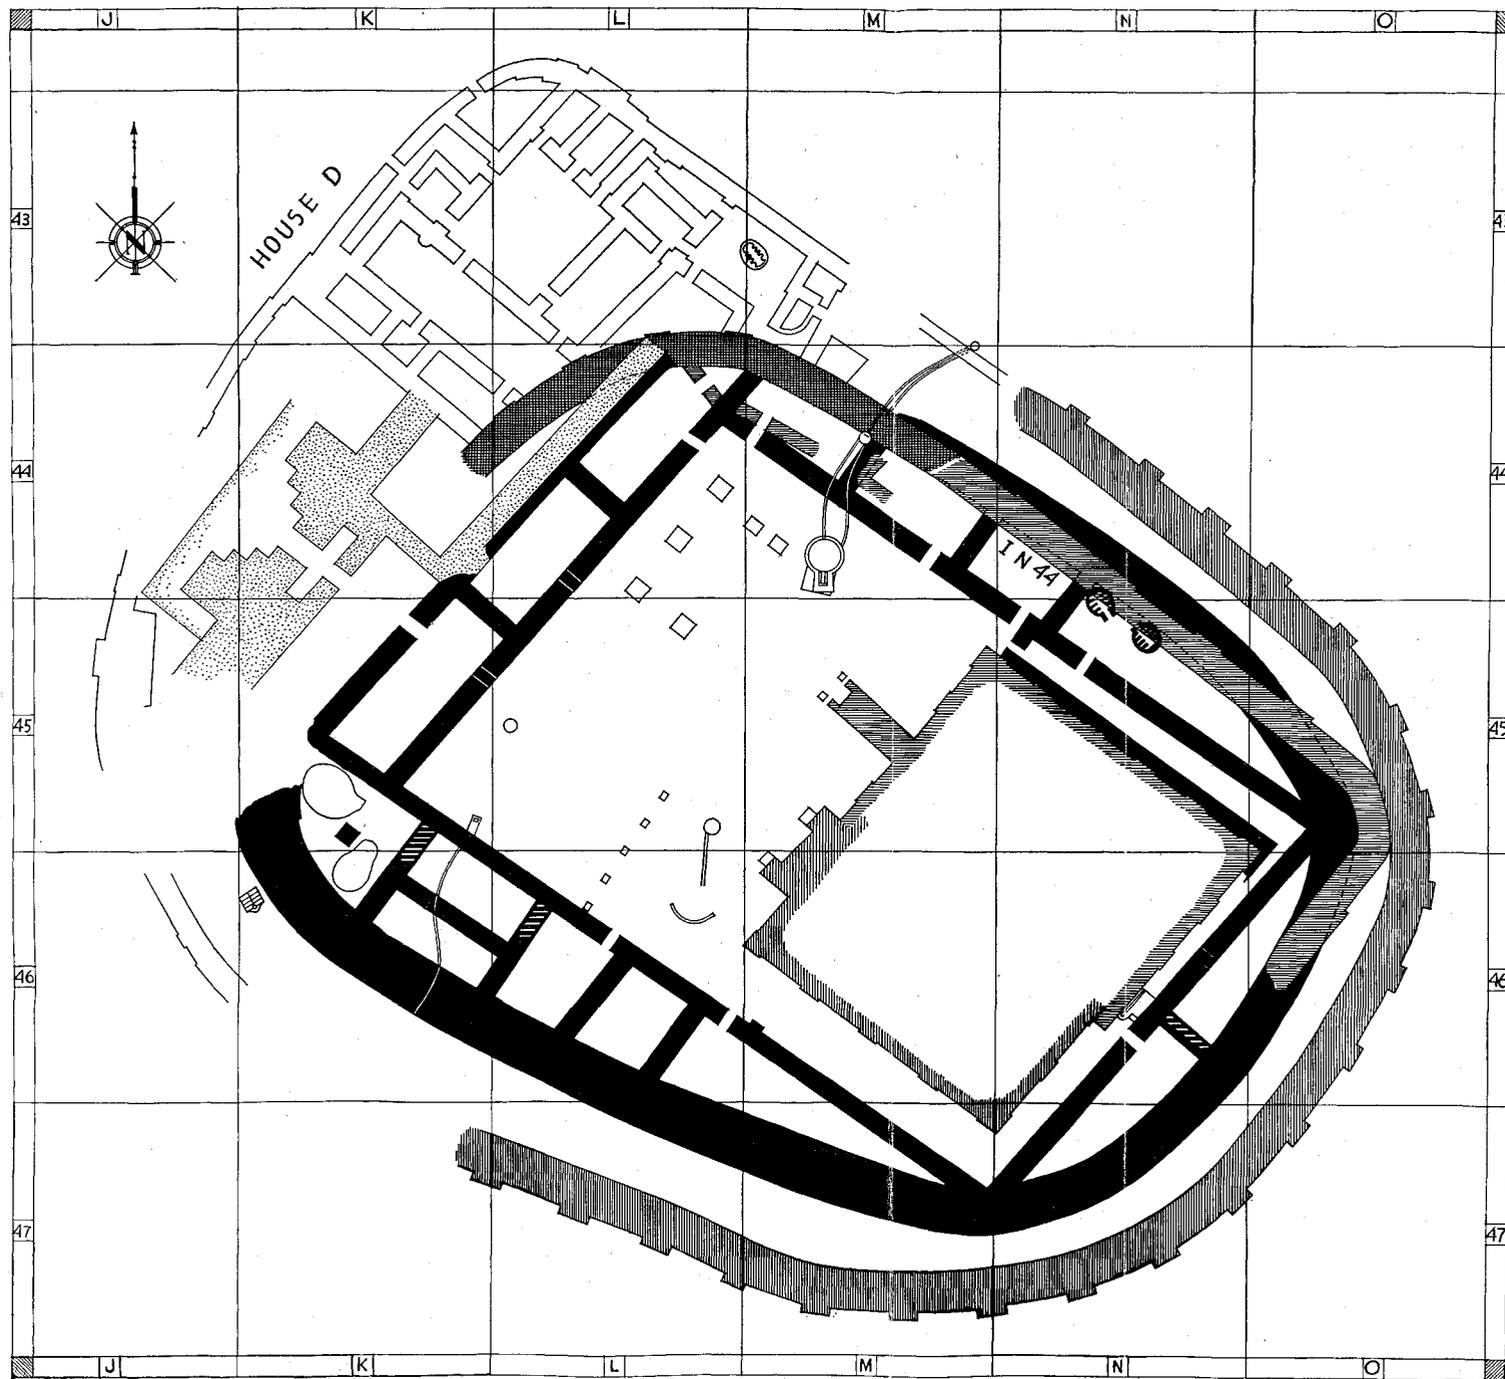
FIG. 40.—Plan of the temple inclosure at Khafaje. Scale, 1:600

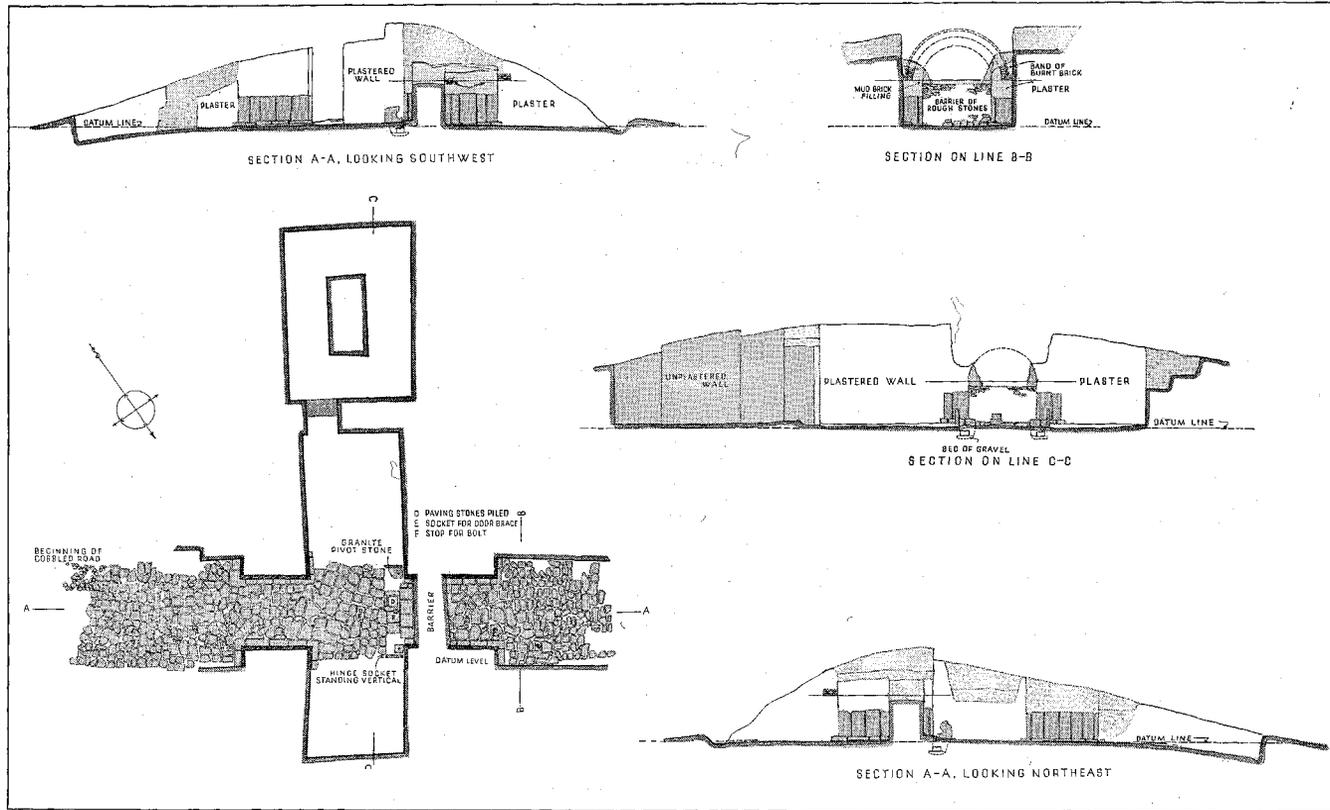
FIG. 53.—Plan and cross-sections of Gate 7. Scale, 1:500

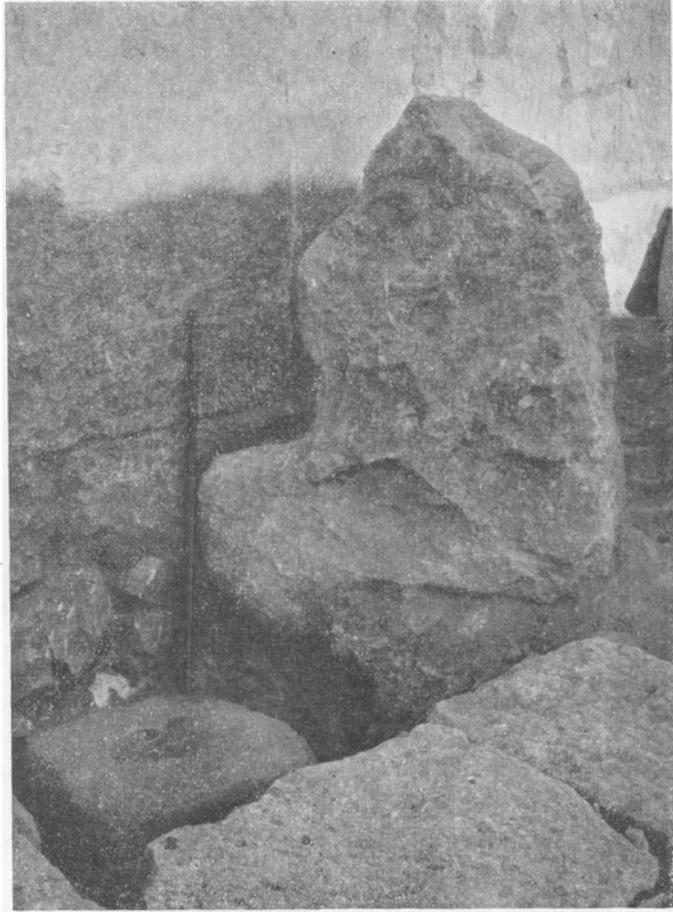
FIG. 55.—One of the pivot stones of Gate 7, with a paving slab standing on edge

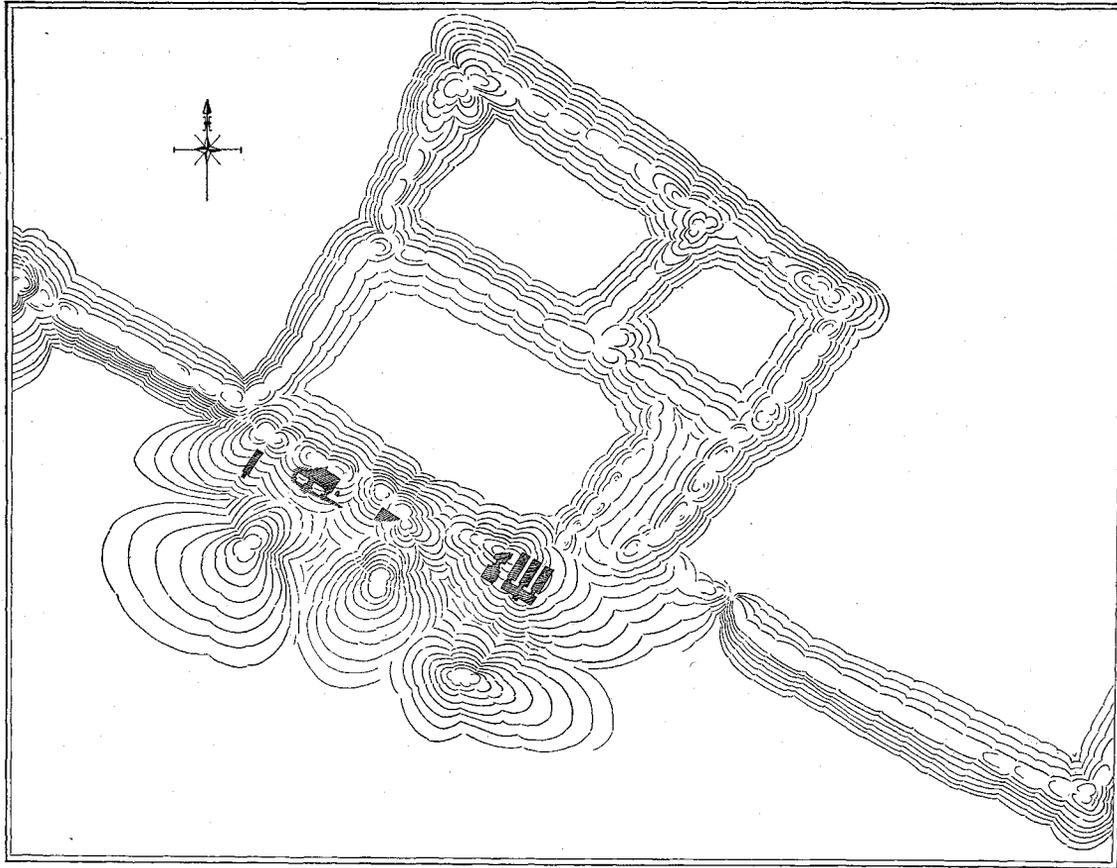
FIG. 56.—Sketch plan of Building F. Scale, 1:4000
